JOINT INVESTIGATION REPORT

INCIDENT NO: 2434155 JIV report S/N: 1030123

1. Fountain Incident Number: 2434155 2. Type of incident* OIL SPILL
3. Name of Location 1.2" IMO RIVER 1 - OGALE PIPELINE
4. Name of nearest community OGALE 5. State: RIVERS 6. LGA ELEME
7. Type of Production facility/Installation OIL PIPELINE
8. Asset owner/District THE SHELL PETROLEUM DEVELOPMENT COMPANY OF NIGERIA LIMITED (SPDC) PIPELINE

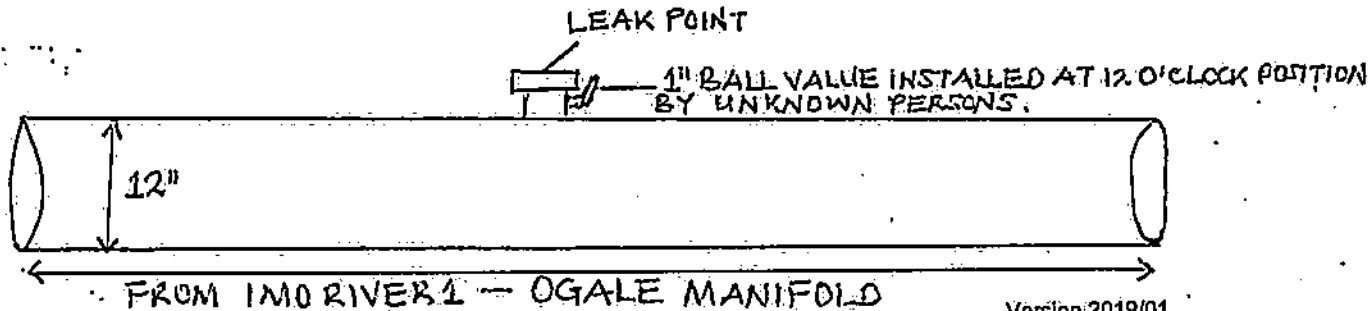
| <input checked="" type="checkbox"/> Crude oil theft (illegal bunkering) point, | <input type="checkbox"/> Saver-pit over flow | <input type="checkbox"/> Third party tampering with Clamp |
| <input checked="" type="checkbox"/> Valve Failure | <input type="checkbox"/> Relief valve failure | <input type="checkbox"/> Accidental 3 rd party equipment impact |

E. GRAPHIC DESCRIPTION OF LEAK POINT (while detail report of the leak point should be contained in the leak report, overview sketch of the site should be added as an appendix 1) A SECTION OF 12" IMO RIVER 1 - OGALE PIPELINE AT OGALE SHOWING 1 NO FAILED 1" BALL VALVE INSTALLED AT 12 O'CLOCK POSITION BY UNKNOWN PERSONS.

REPAIR BY CLAMPING ON - GOING
