# JOINT INVESTIGATION REPORT

INCIDENT NO: 2422923 JIV report S/N: 1030223

1. Fountain Incident Number: 2422923 2. Type of incident: OIL SPILL  
3. Name of Location: 16" NUN RIVER - KOLD CREEK PIPELINE  
4. Name of nearest community: OTUEGNE 5. State: BAYELSA 6. LGA: OGBIA  
7. Type of Production facility/Installation: OIL PIPELINE  
8. Asset owner/District: THE SHELL PETROLEUM DEVELOPMENT COMPANY OF NIGERIA LIMITED (SPDC) / PIPELINE

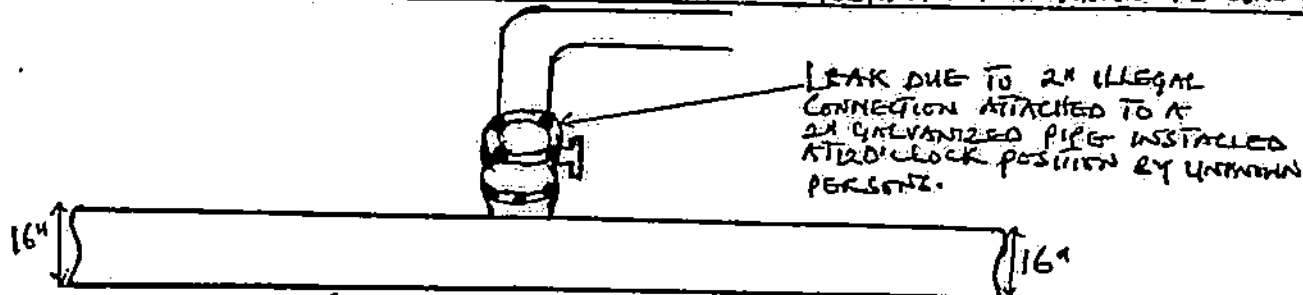
| <input checked="" type="checkbox"/> Failed Weld-on illegal hot tap valve | <input type="checkbox"/> Failed Clamp, | <input type="checkbox"/> Missing Pipeline/Flowline |
| <input checked="" type="checkbox"/> Crude oil theft (illegal bunkering) point, | <input type="checkbox"/> Saver-pit over flow | <input type="checkbox"/> Third party tampering with Clamp |

**E. GRAPHIC DESCRIPTION OF LEAK POINT** (while detail report of the leak point should be contained in the leak report, overview sketch of the site should be added as an appendix 1) A SECTION OF 16" NUN RIVER - KOLD CREEK PIPELINE AT OTUEQUE SHOWING A 2" ILLEGAL CONNECTION ATTACHED TO A 2" GALVANIZED PIPE INSTALLED AT 12 O'CLOCK POSITION BY UNKNOWN PERSONS.

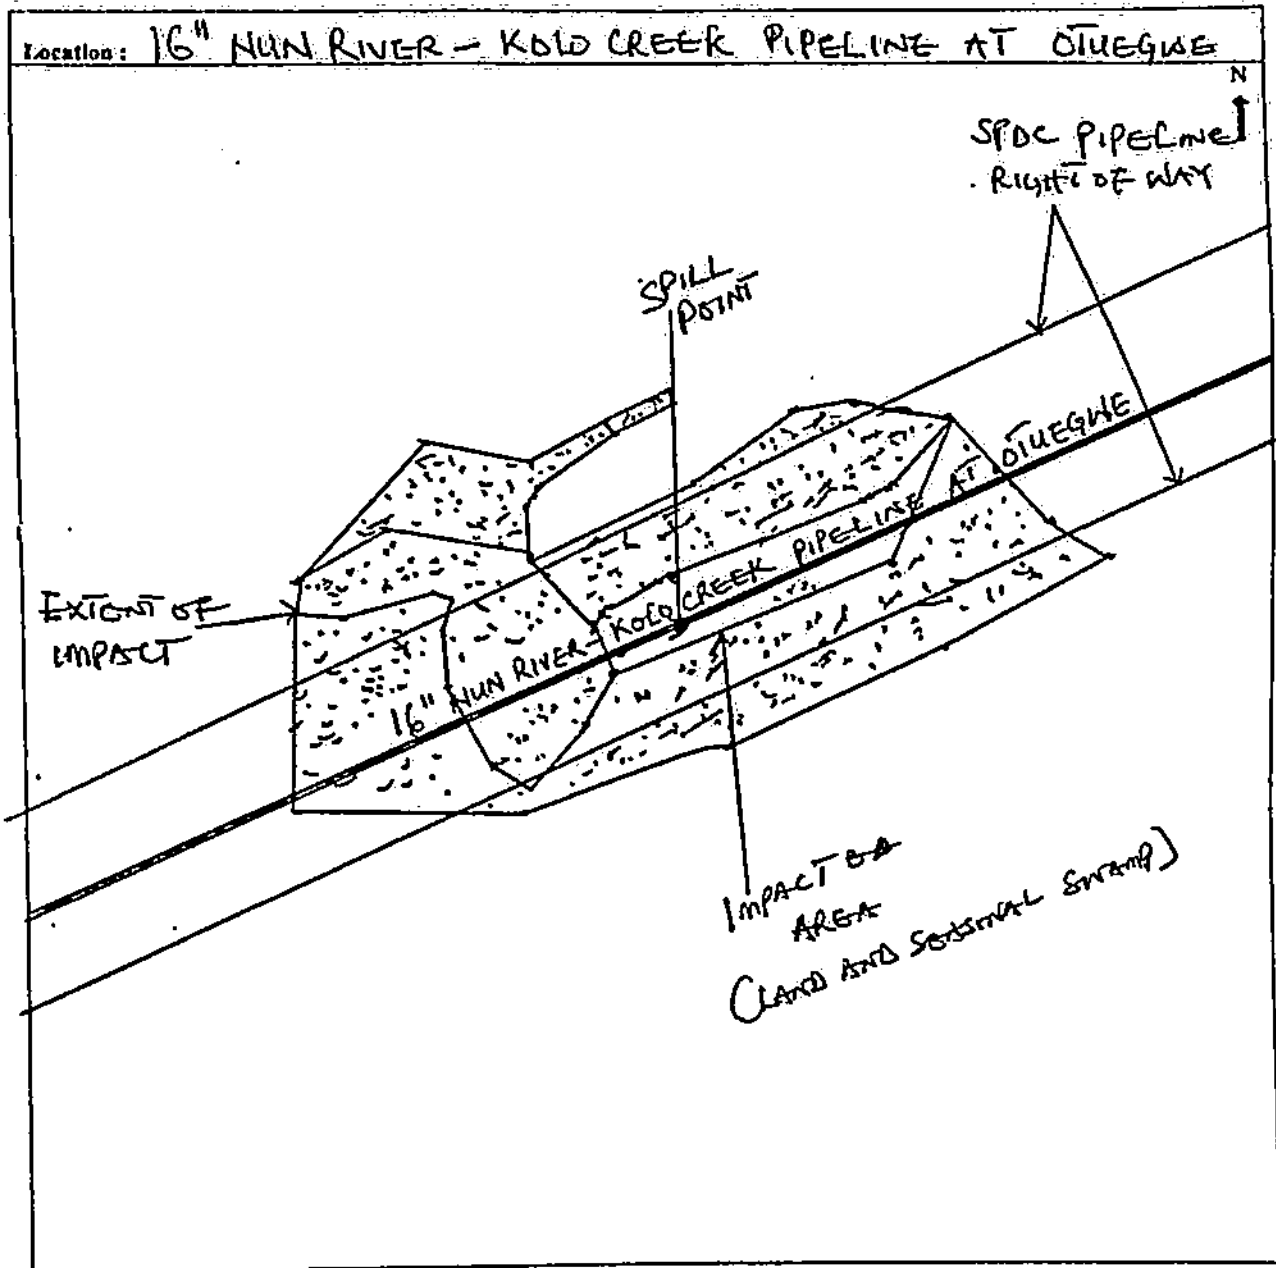
## f. Appendix i: Overview sketch of the site

- Total calculated area of impact 2.57 ha
- Impact within SPDC R.O.W. YES
- Impact outside SPDC R.O.W. YES
