JOINT INVESTIGATION REPORT

INCIDENT NO: 2429453 JIV report S/N: 1030222

1. Fountain Incident Number: 2429453 2. Type of incident: OIL SPILL
3. Name of Location: 10" GBARAN OIL MANIFOLD - GBARAN CPF BULKLINE
4. Name of nearest community: ONDPA 5. State: BAYELSA 6. LGA: YENAGEA
7. Type of Production facility/Installation: OIL PIPELINE
8. Asset owner/District: THE SHELL PETROLEUM DEVELOPMENT COMPANY OF NIGERIA LIMITED (SPDC)/CENTRAL HUB

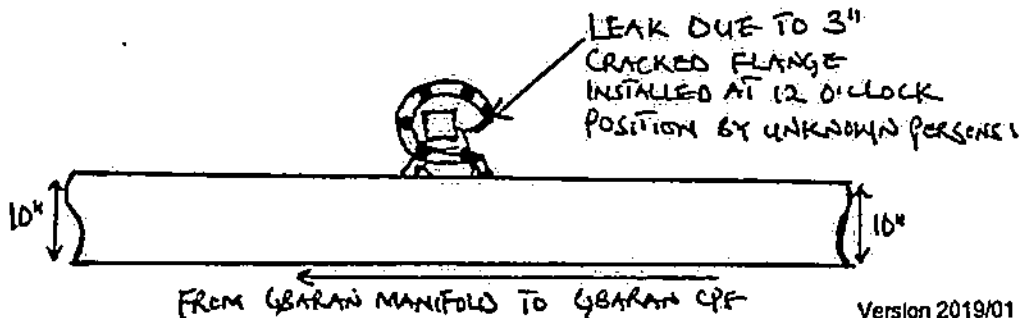
| <input checked="" type="checkbox"/> Crude oil theft (illegal bunkering) point, | <input type="checkbox"/> Saver-pit over flow | <input type="checkbox"/> Third party tampering with Clamp |

E. GRAPHIC DESCRIPTION OF LEAK POINT (while detail report of the leak point should be contained in the leak report, overview sketch of the site should be added as an appendix IIA SECTION OF 10" GBARAN OIL MANIFOLD - GBARAN CPF BULKLINE AT ONOPA SHOWING A 3" CRACKED FLANGE INSTALLED AT 12 O'CLOCK POSITION BY UNKNOWN PERSONS
