JOINT INVESTIGATION REPORT

INCIDENT NO: 2524811 JIV report S/N: 1030185

1. Fountain Incident Number: 2524811 2. Type of incident* OIL SPILL
3. Name of Location IKU OKORDIA - RUMUEKPE PIPELINE
4. Name of nearest community IKATA 5. State: RIVERS 6. LGA AHOADA-EAST
7. Type of Production facility/Installation OIL PIPELINE
8. Asset owner/District THE SHELL PETROLEUM DEVELOPMENT COMPANY OF NIGERIA LIMITED (SPDC)/PIPELINE

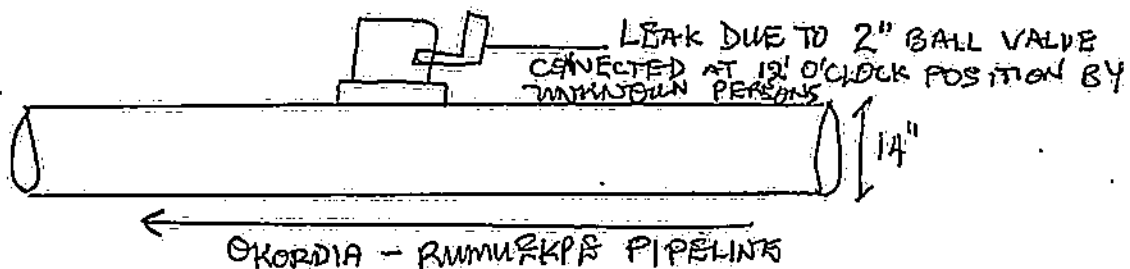
JOINT INVESTIGATION TEAM OBSERVED THAT THE LEAK IS FROM A PREVIOUSLY REPORTED NON-LEAKING ILLEGAL CONNECTION (REF FID-2502055).

E. GRAPHIC DESCRIPTION OF LEAK POINT (while detail report of the leak point should be contained in the leak report, overview sketch of the site should be added as an appendix 1) A SECTION OF 14" OKORDIA RUMURKPE PIPELINE AT IKASA SHOWING A 2" BALL VALVE CONNECTED TO THE PIPELINE AT 12 O'CLOCK POSITION BY UNKNOWN PERSONS.

OIL SPILL RESPONSE / LEAK POINT REPAIR
