# JOINT INVESTIGATION REPORT

INCIDENT NO: 2527883 JIV report S/N: 1030206

1. Fountain Incident Number: 2527883 2. Type of incident\* OIL SPILL  
3. Name of Location 18" ASSA - RUMUEKPE PIPELINE  
4. Name of nearest community UMUDIOGA / AKPABU 5. State: RIVER 6. LGA EMOHUA  
7. Type of Production facility/Installation OIL PIPELINE  
8. Asset owner/District THE SHELL PETROLEUM DEVELOPMENT COMPANY OF NIGERIA LTD (SPDC) / PIPELINE

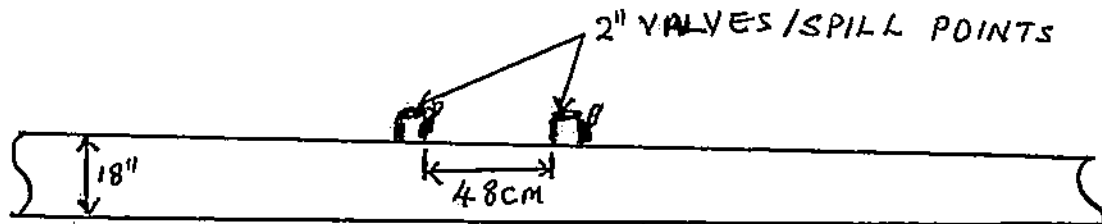
| <input type="checkbox"/> Failed Weld-on illegal hot tap valve | <input type="checkbox"/> Failed Clamp, | <input checked="" type="checkbox"/> Missing Pipeline/Flowline |
| <input checked="" type="checkbox"/> Crude oil theft (illegal bunkering) point, | <input type="checkbox"/> Saver-pit over flow | <input type="checkbox"/> Third party tampering with Clamp |

**E. GRAPHIC DESCRIPTION OF LEAK POINT** (while detail report of the leak point should be contained in the leak report, overview sketch of the site should be added as an appendix 1) **A SECTION OF 18" ASSA - RUMUEKPE PIPELINE AT UMUDIOPA/AKPABU SHOWING 2NDS 2" VALVES CRUDE THEFT POINTS INSTALLED AT 12 O'CLOCK POSITIONS 48CM APART, BY UNKNOWN PERSONS.**

REPAIR BY CLAMPING

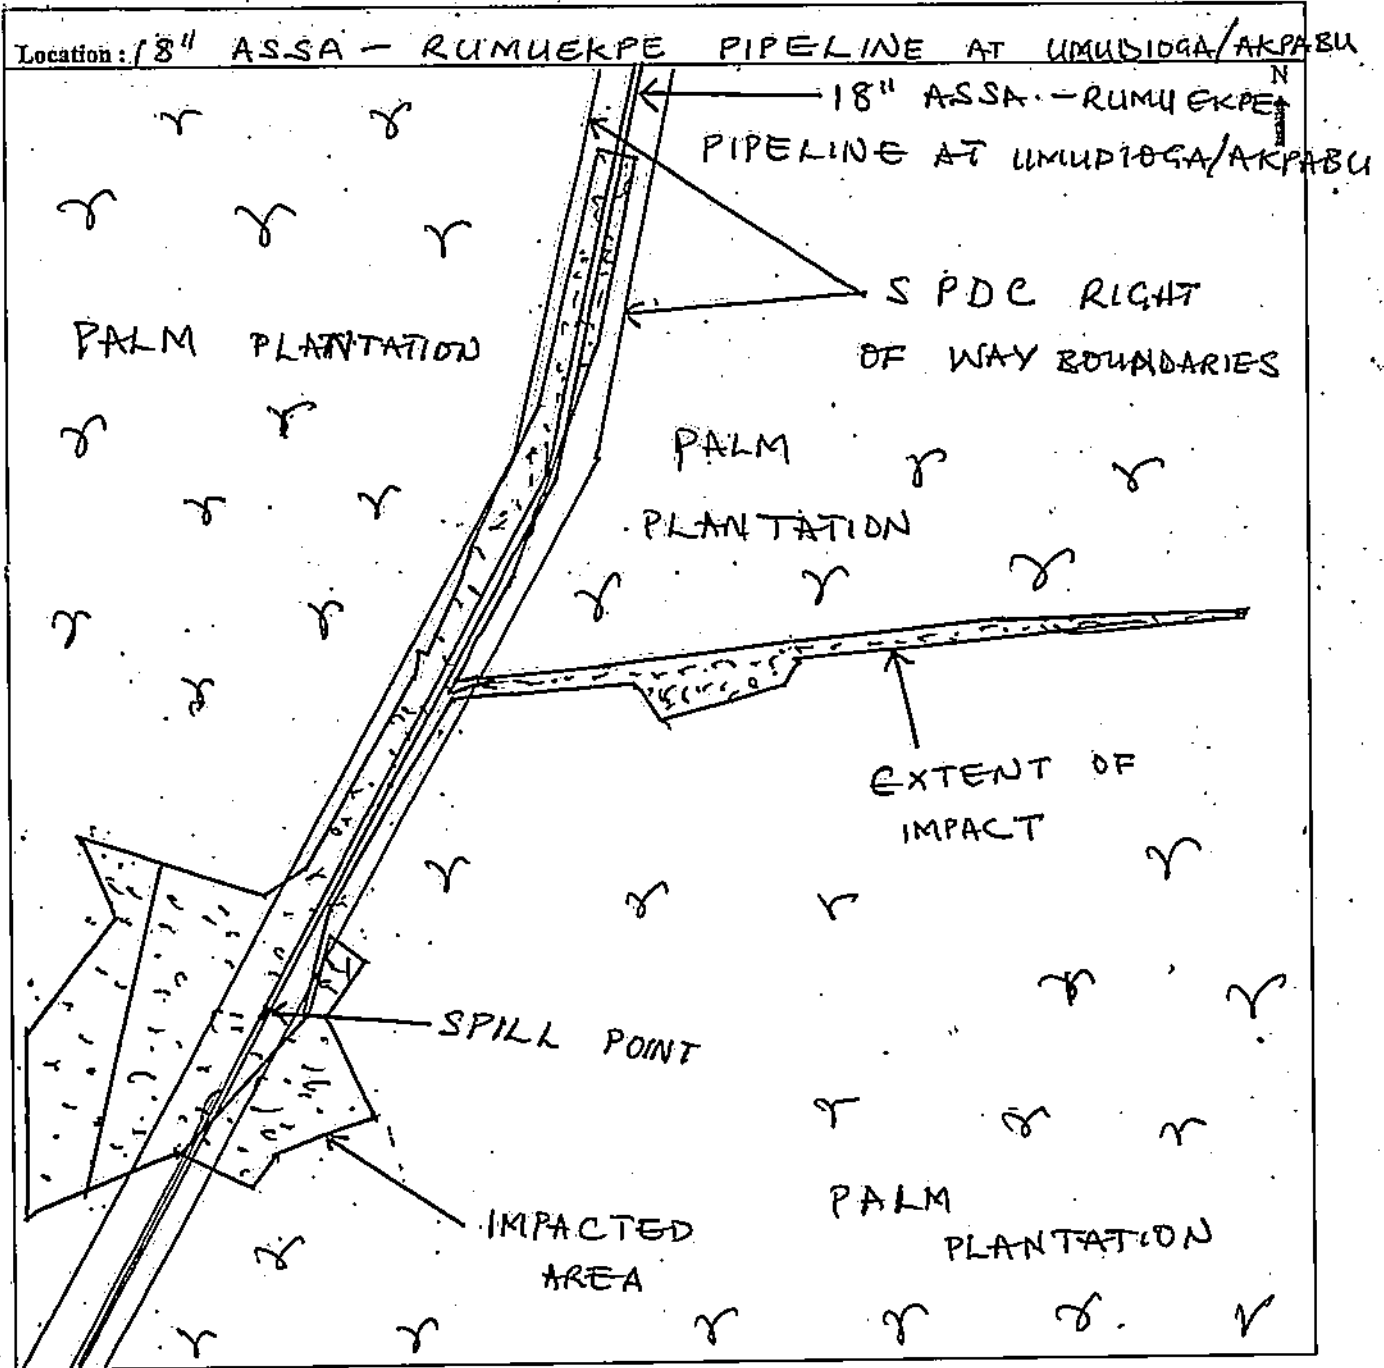
f. Appendix 1: Overview sketch of the site

- Total calculated area of impact 1.085ha
- Impact within SPDC R.O.W. YES
- Impact outside SPDC R.O.W. YES
