JOINT INVESTIGATION REPORT

INCIDENT NO: 2527038 JIV report S/N: 1030187

1. Fountain Incident Number: 2527038 2. Type of incident* OIL SPILL
3. Name of Location 20" KOLOCREEK - RUMUKEPE PIPELINE
4. Name of nearest community ODAU (KP19) 5. State: RIVERS 6. LGA ABUA / ODUAL
7. Type of Production facility/Installation OIL PIPELINE
8. Asset owner/District THE SHELL PETROLEUM DEVELOPMENT COMPANY OF NIGERIA LIMITED / PIPELINE

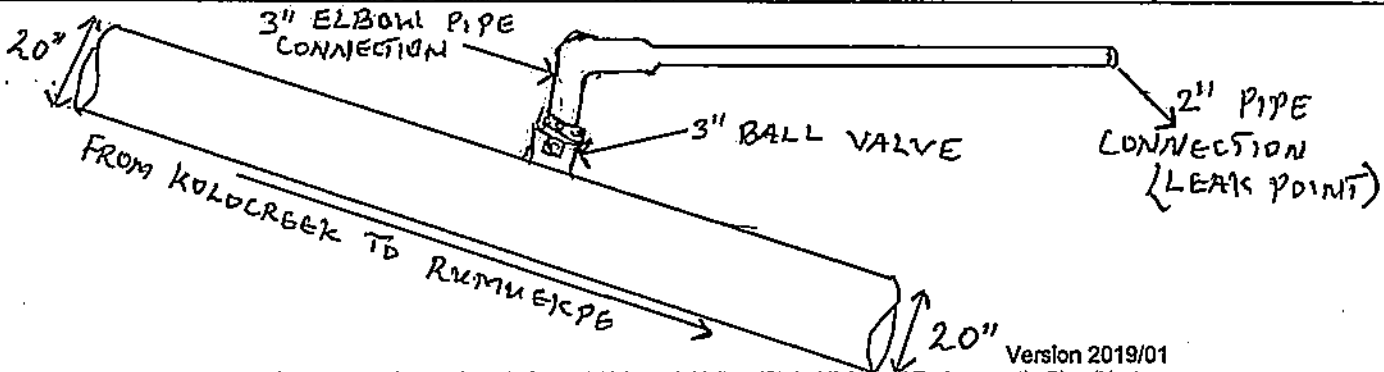
BURNT AREA WAS OBSERVED BY THE JOINT INVESTIGATION TEAM.

| <input checked="" type="checkbox"/> Crude oil theft (illegal bunkering) point, | <input type="checkbox"/> Saver-pit over flow | <input type="checkbox"/> Third party tampering with Clamp |

SECTION OF 20" KOLOCREEK - RUMMEKPE PIPELINE AT ODAU (KP 19) SHOWING CRUDE OIL THEFT POINT INSTALLED AT 12 O'CLOCK POSITION.

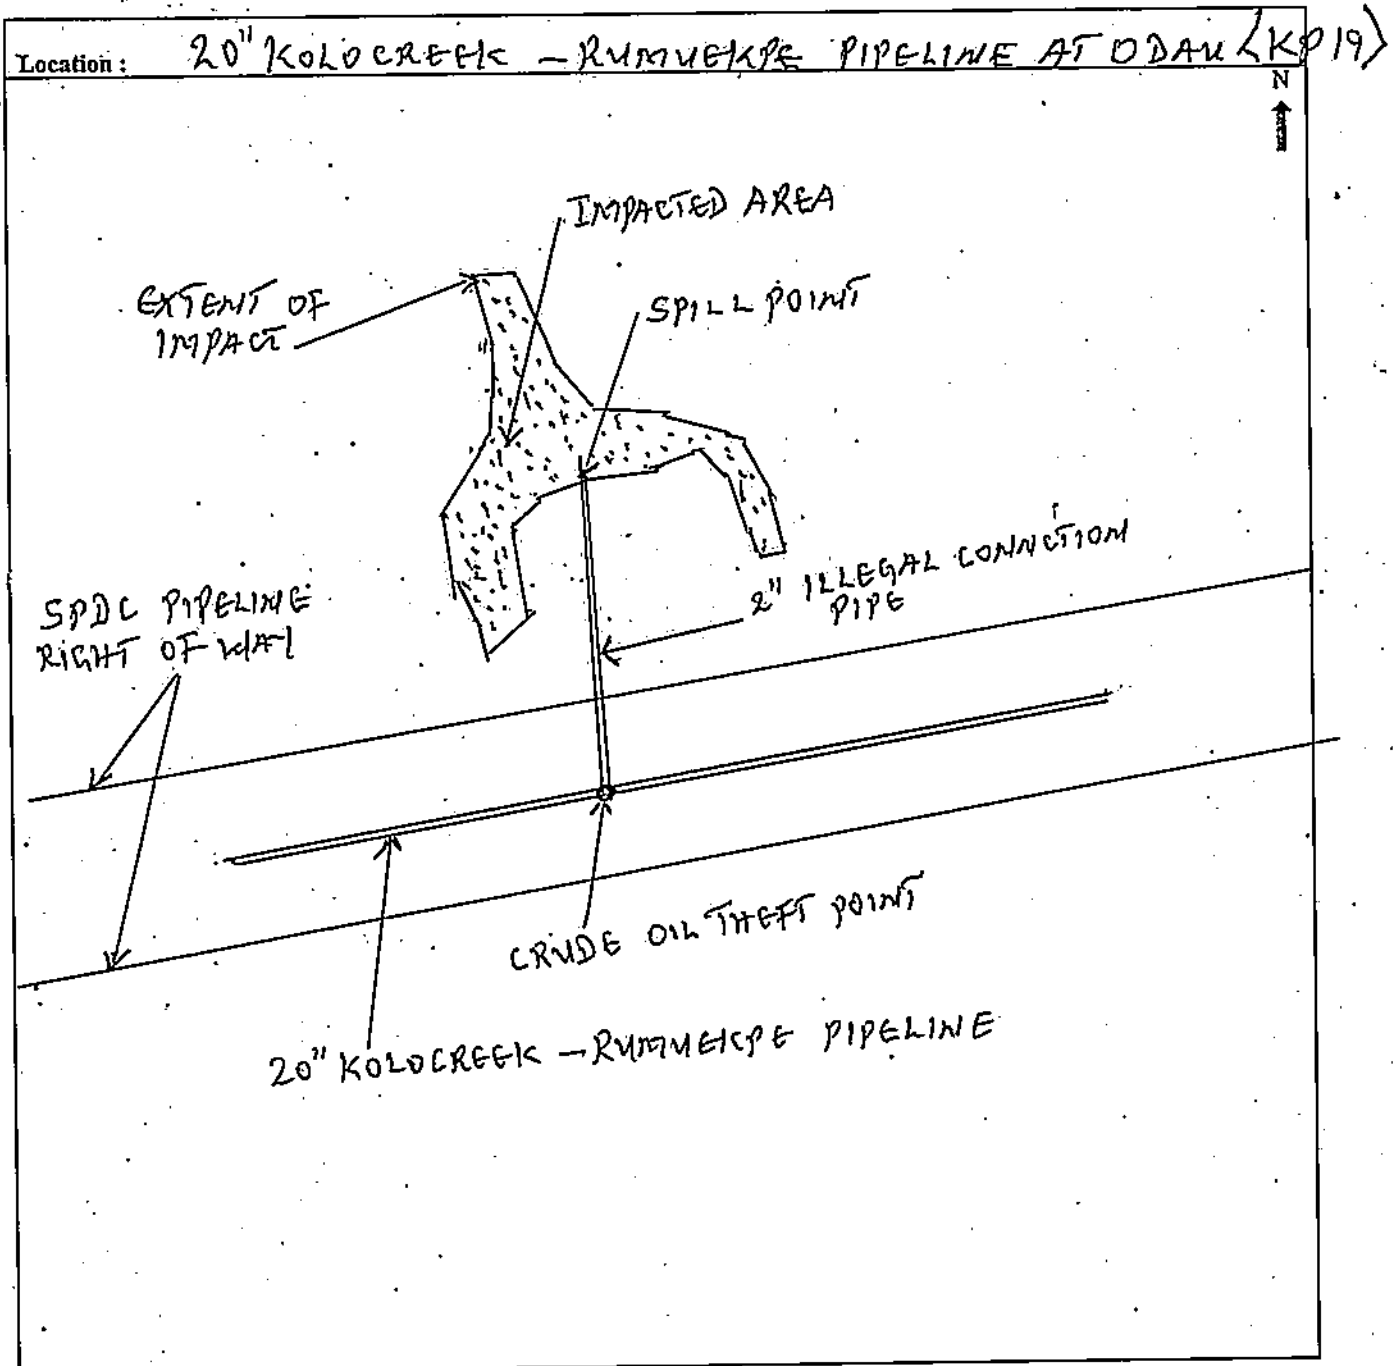
f. Appendix d: Overview sketch of the site

- Total-calculated area of impact 0.030845 Ha
- Impact within SPDC R.O.W. No
- Impact outside SPDC R.O.W. YES
