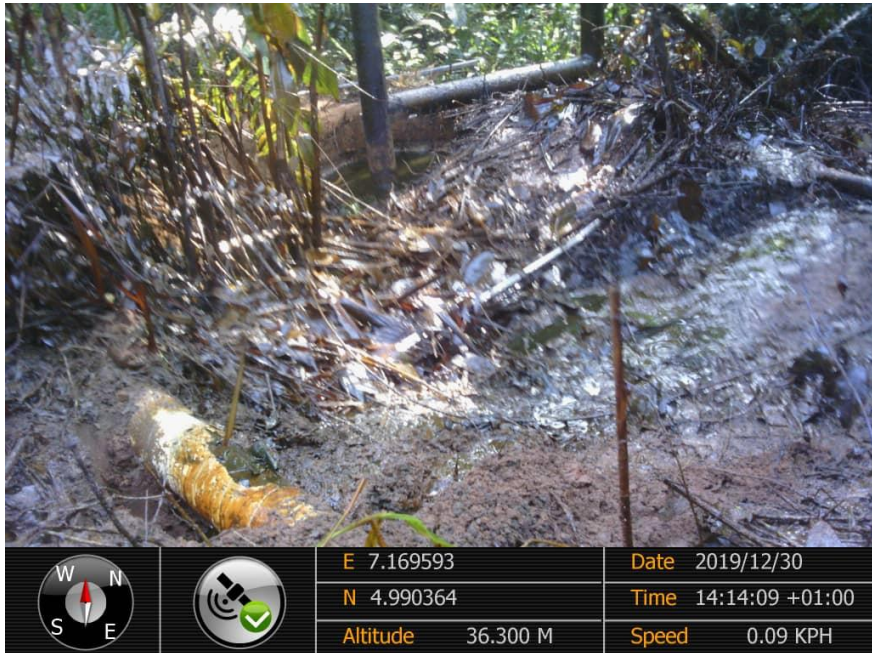
**Overview:** Part of spill impact on on Imo River Well 25S Flowline at Odagwa. Picture was taken during Joint Investigation of 30<sup>th</sup> December 2019.

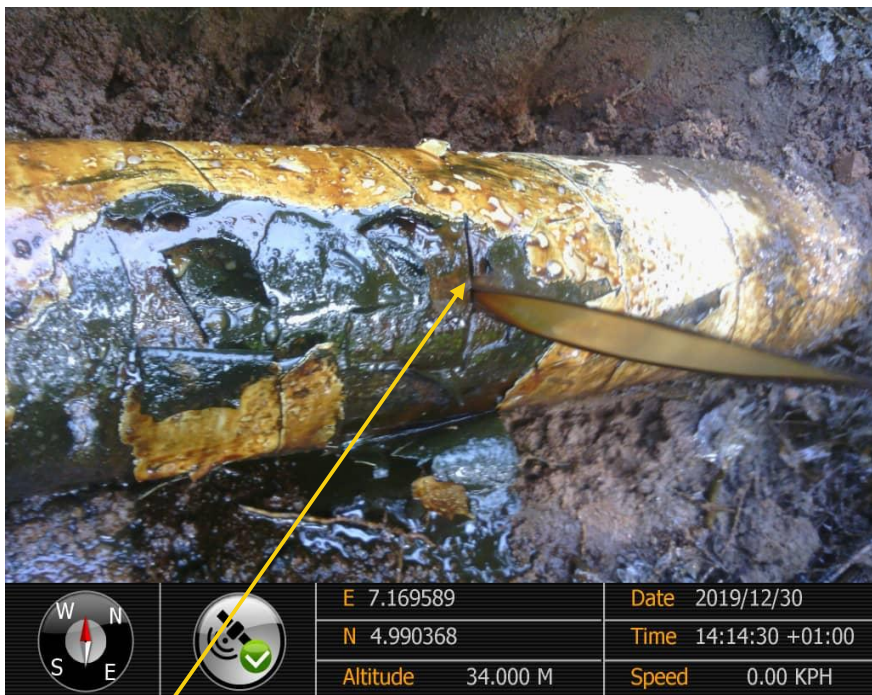
**Close-up:** Hack Saw Cut at 1 o'clock position on Imo River Well 25S Flowline at Odagwa. Picture was taken during Joint Investigation of 30<sup>th</sup> December 2019.
