JOINT INVESTIGATION REPORT

INCIDENT NO: 2537501 JIV report S/N: 1030195

1. Fountain Incident Number: 2537501 2. Type of incident* OIL SPILL
3. Name of Location MID RIVER WELL 25S FLOWLINE
4. Name of nearest community ODAGWA 5. State: RIVERS 6. LGA ETCHE
7. Type of Production facility/Installation OIL FLOWLINE
8. Asset owner/District THE SHELL PETROLEUM DEVELOPMENT COMPANY

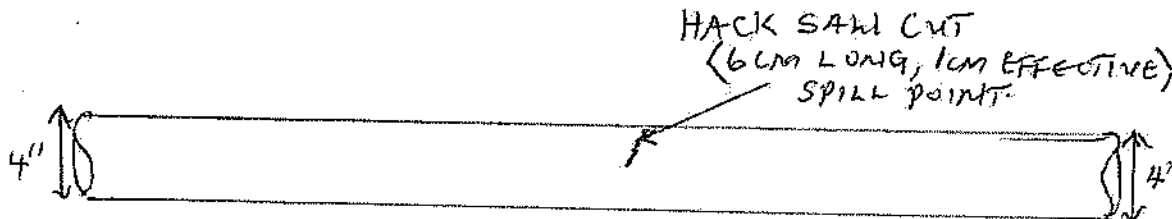
| <input type="checkbox"/> Drilled hole | <input checked="" type="checkbox"/> Hack saw cut | <input type="checkbox"/> Tear (_____) |

- Third party interference (Sabotage ; crude theft ; Line theft ; Accidental 3rd party damage
 Operational Others (including Mystery spills) _____

SECTION OF IMO RIVER WELL 255 FLOWLINE AT ODAGWA SHOWING HACK SAW CUT AT 10' CLOCK POSITION.
