JOINT INVESTIGATION REPORT

INCIDENT NO: 2533005 JIV report S/N: 1030156

1. Fountain Incident Number: 2533005 2. Type of incident* OIL SPILL
3. Name of Location 20" KOLO-CREEK TRUNK LINE
4. Name of nearest community OKPOROWD 5. State: RIVERS 6. LGA AHDADA EAST
7. Type of Production facility/Installation OIL PIPELINE
8. Asset owner/District THE SHELL PETROLEUM DEVELOPMENT COMPANY OF NIGERIA LIMITED / PIPELINE

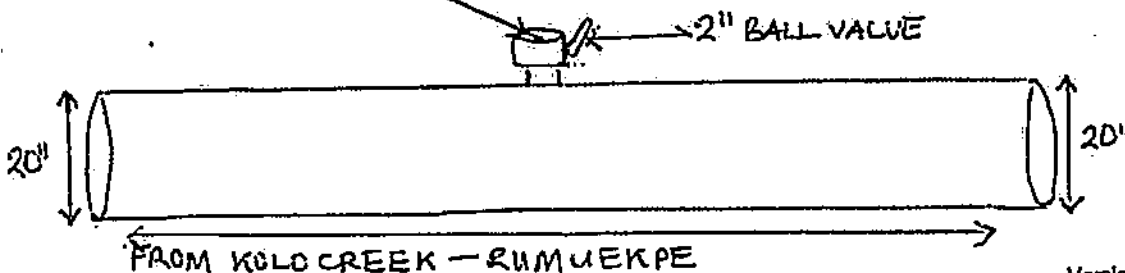
E. GRAPHIC DESCRIPTION OF LEAK POINT (while detail report of the leak point should be contained in the leak report, overview sketch of the site should be added as an appendix 1)

SECTION OF 20" KOLO CREEK TRUNK LINE TO RUMUEKPE AT OKPORDWO SHOWING CRUDE OIL THEFT POINT INSTALLED AT 12 O'CLOCK POSITION.
LEAK POINT
