JOINT INVESTIGATION REPORT

INCIDENT NO: 2531864 JIV report S/N: 1030192

1. Fountain Incident Number: 2531864 2. Type of incident* OIL SPILL
3. Name of Location 1.8" ASSA-RUMU EKPE TRUNKLINE
4. Name of nearest community ASSA 5. State: IMO 6. LGA HAJI ESSEMA
7. Type of Production facility/Installation OIL PIPELINE
8. Asset owner/District THE SHELL PETROLEUM DEVELOPMENT COMPANY OF NIGERIA LIMITED

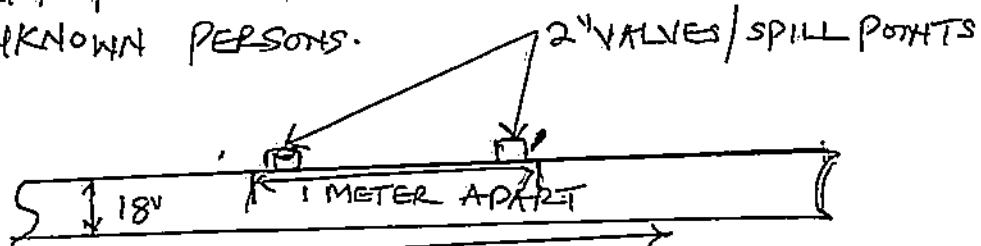
| <input checked="" type="checkbox"/> Crude oil theft (illegal bunkering) point, | <input type="checkbox"/> Saver-pit over flow | <input type="checkbox"/> Third party tampering with Clamp |

A SECTION OF 18" ASSA - RUMUEKPE TRUNK LINE AT ANARA SHOWING 2 NUMBERS 2" VALVES CRUDE THEFT POINTS INSTALLED AT 12 O'CLOCK POSITIONS 1 METER APART BY UNKNOWN PERSONS.
