# JOINT INVESTIGATION REPORT

INCIDENT NO: 2262964 JIV report S/N: 0240

1. Spill incident Number: 2262964 2. Type of incident\*: OIL SPILL  
3. Name of Location: 24" NKPOKU - BOMU PIPELINE  
4. Name of nearest community: EGBALOR 5. State: RIVERS 6. LGA: ELEME  
7. Type of Production facility/Installation: OIL PIPELINE  
8. Asset owner/District: THE SHELL PETROLEUM DEVELOPMENT COMPANY OF NIGERIA LIMITED/PIPELINE

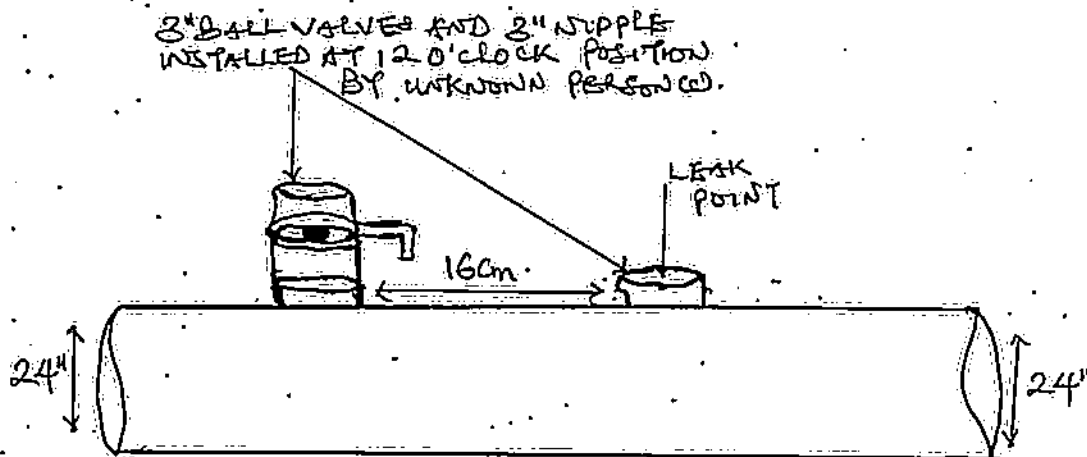
Additional observations around the spill point: THE JOINT INVESTIGATION TEAM OBSERVED BURNT SOIL AROUND THE SPILL POINT AREA.

| <input checked="" type="checkbox"/> Failed Weld-on illegal hot tap valve | <input type="checkbox"/> Failed Clamp | <input type="checkbox"/> Missing Pipeline/Flowline |
| <input checked="" type="checkbox"/> Crude oil theft (illegal bunkering) point | <input type="checkbox"/> Saver-pit over flow | <input type="checkbox"/> Third party tampering with Clamp |

**E. GRAPHIC DESCRIPTION OF LEAK POINT** (while detailed report of the leak point should be contained in the leak report, overview sketch of the site should be added as an appendix 1) A SECTION OF 24" NKPOKU - BOMU PIPELINE AT EGALOR SHOWING A 3" BALL VALVE AND 3" NIPPLE BOTH INSTALLED AT 12 O'CLOCK POSITION BY UNKNOWN PERSONS.

FROM NKPOKU - BOMU PIPELINE

RECOVERY AND REPAIR ACTIVITIES ARE ONGOING
