# JOINT INVESTIGATION REPORT

INCIDENT NO: 2264342 JIV report S/N: 0244

1. Spill incident Number: 2264342 2. Type of incident\* OIL SPILL  
3. Name of Location 18" ASSA - RUMUEKPE (TRUNKLINE) PIPELINE  
4. Name of nearest community AWARA 5. State: IMO 6. LGA OHAST EGBEMA  
7. Type of Production facility/Installation OIL PIPELINE  
8. Asset owner/District THE SHELL PETROLEUM DEVELOPMENT COMPANY OF NIGERIA LIMITED PIPELINE

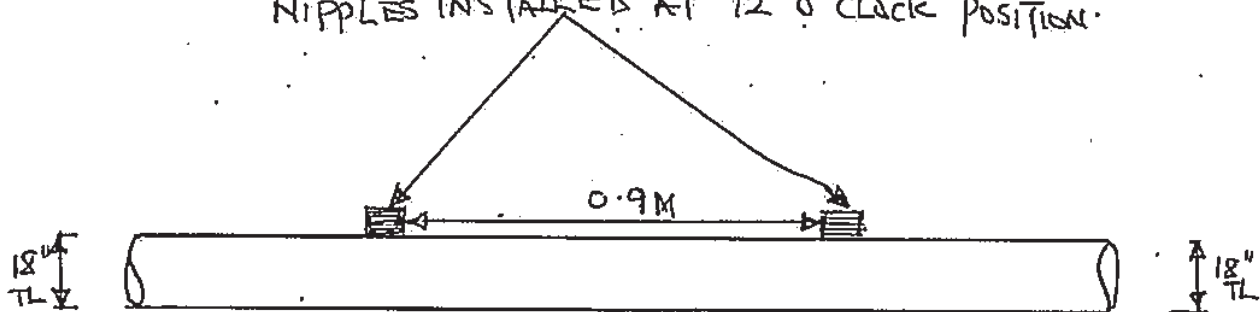
**SECTIONAL VIEW OF 18" ASSA - RUMUEKPE (TRUNKLINE) PIPELINE.**

Additional observations around the spill point: ON EXCAVATION OF THE INCIDENT POINT THE JOINT INVESTIGATION TEAM OBSERVED ~~(A) (THE) (THE)~~ THE USE OF SAND BAGS TO CONSEAL THE ILLEGAL THEFT POINTS.

**AT AWARA SHOWING:- FAILED 2 NUMBERS OF 2" LEAKING NIPPLES..**

FAILED 2\*NUMBER OF 2" BALL VALVE  
NIPPLES INSTALLED AT 12 O' CLOCK POSITION.

CRUDE RECOVERY WORK AND REPAIR WORK BY CLAMPING  
ON-GOING AND WAS LATER COMPLETED.
