JOINT INVESTIGATION REPORT

INCIDENT NO: 2265934 JIV report S/N: 0248

1. Spill incident Number: 2265934 2. Type of incident*: OIL SPILL
3. Name of Location 28th NKPOKU - BOMU PIPELINE
4. Name of nearest community ALETO 5. State: RIVERS 6. LGA ELEME
7. Type of Production facility/Installation OIL PIPELINE
8. Asset owner/District THE SHELL PETROLEUM DEVELOPMENT COMPANY OF NIGERIA LIMITED (SPDC) / PIPELINE

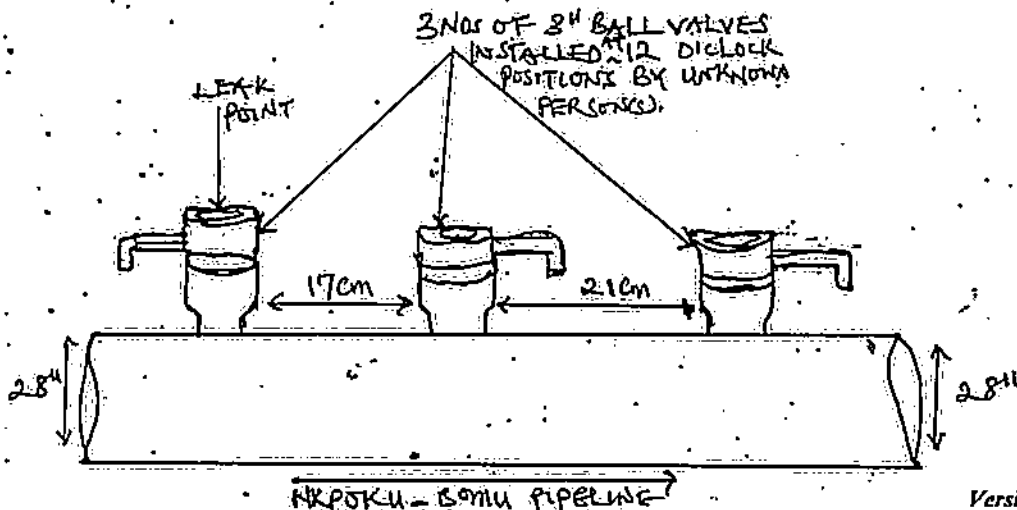
| <input checked="" type="checkbox"/> Failed Weld-on illegal hot tap valve | <input type="checkbox"/> Failed Clamp | <input type="checkbox"/> Missing Pipeline/Flowline |
| <input checked="" type="checkbox"/> Crude oil theft (illegal bunkering) point | <input type="checkbox"/> Saver-pit over flow | <input type="checkbox"/> Third party tampering with Clamp |

E. GRAPHIC DESCRIPTION OF LEAK POINT (while detailed report of the leak point should be contained in the leak report, overview sketch of the site should be added as an appendix 1) A SECTION OF 28" NKPOKU-BOMU PIPELINE AT ALETO SHOWING A 3 NOS OF 2" BALL VALVES INSTALLED AT 12 O'CLOCK POSITIONS BY UNKNOWN PERSONS.

RECOVERY AND REPAIR ACTIVITIES ARE ONGOING

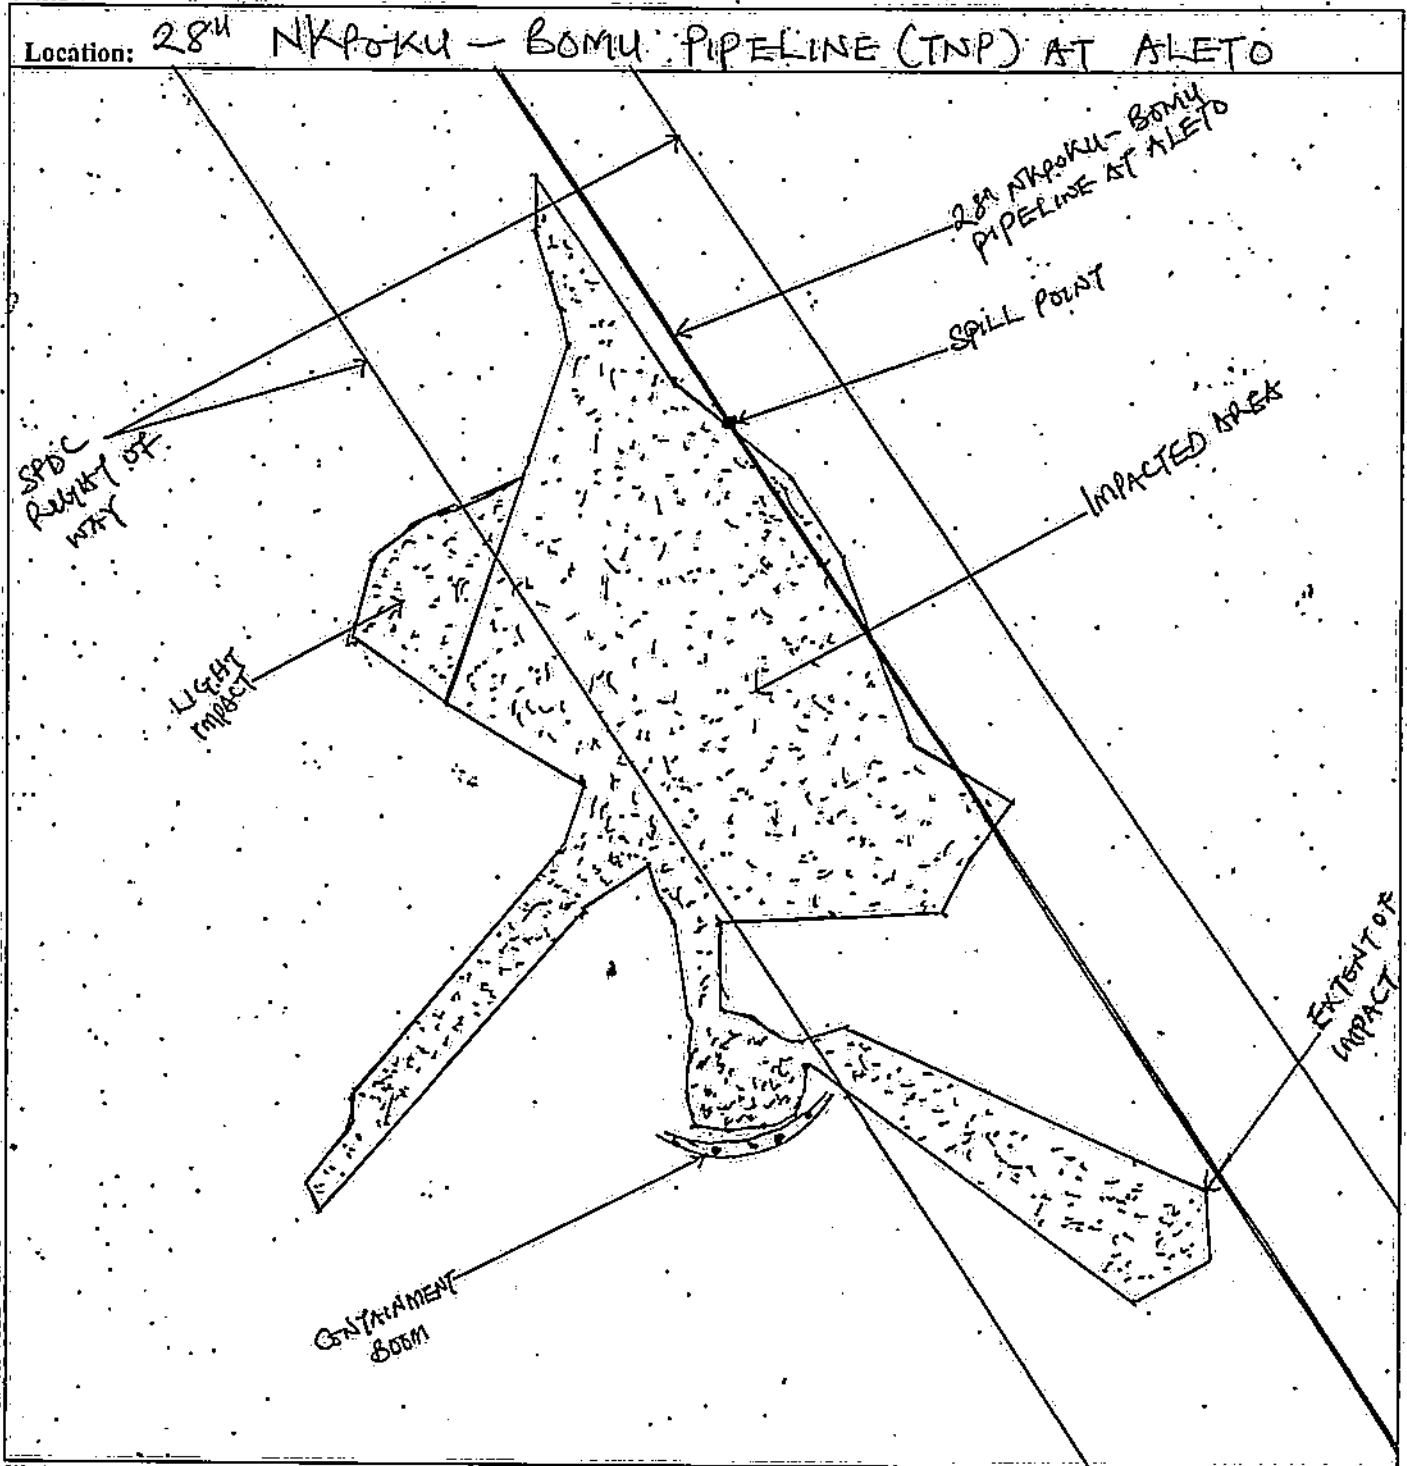
f. Appendix 1: Overview sketch of the site

- Total calculated area of impact 0.159891 HA
- Impact within R.O.W YES
- Impact outside R.O.W YES
