JOINT INVESTIGATION REPORT

INCIDENT NO: 2259416 JIV report S/N: 0201

1. Spill incident Number: 2259416 2. Type of incident: OIL SPILL
3. Name of Location: 12" IMO RIVER - OGALE PIPELINE
4. Name of nearest community: UKUAKU 5. State: ABIA 6. LGA: UKWA-WEST
7. Type of Production facility/Installation: OIL PIPELINE
8. Asset owner/District: THE SHELL PETROLEUM DEVELOPMENT COMPANY OF NIGERIA LIMITED (SPDC) / PIPELINE

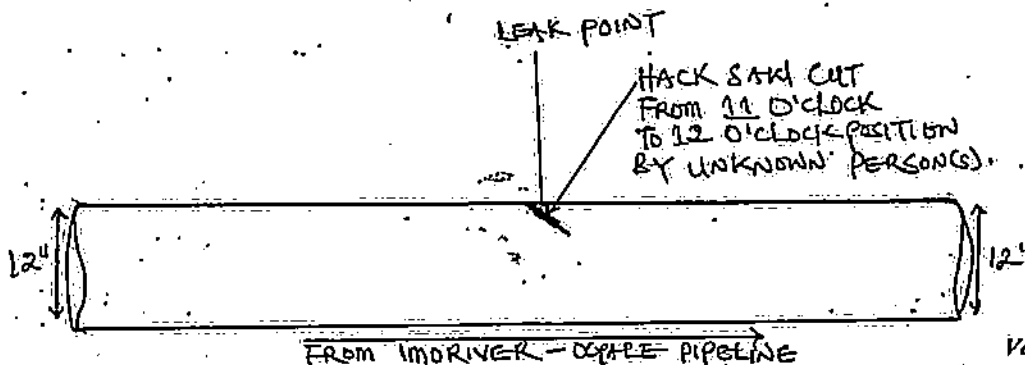
| <input type="checkbox"/> Drilled hole | <input checked="" type="checkbox"/> Hack saw cut | <input type="checkbox"/> Tear (_____) |

- Third party interference (Sabotage ; crude theft ; Line theft ; Accidental 3rd party damage
 Operational Mystery spills Others(specify) _____

E. GRAPHIC DESCRIPTION OF LEAK POINT (while detailed report of the leak point should be contained in the leak report, overview sketch of the site should be added as an appendix) A SECTION OF 12" IMO RIVER - OGARE PIPELINE AT UZUAKU SHOWING A HACK SAW CUT FROM 11 O'CLOCK TO 12 O'CLOCK POSITION BY UNKNOWN PERSON(S).

CRUDE OIL RECOVERY AND REPAIR ACTIVITIES ARE ONGOING
