JOINT INVESTIGATION REPORT

INCIDENT NO: 2259160 JIV report S/N: 0227

1. Spill incident Number: 2259160 2. Type of incident* OIL SPILL
3. Name of Location 20" KOLOCREEK - RUMMEKPE (TRUNKLINE) PIPELINE
4. Name of nearest community ODAU (Km9) 5. State: RIVERS 6. LGA ABUA/ODUAL
7. Type of Production facility/Installation OIL PIPELINE
8. Asset owner/District THE STEEL PETROLEUM DEVELOPMENT COMPANY OF NIGERIA LIMITED / PIPELINE

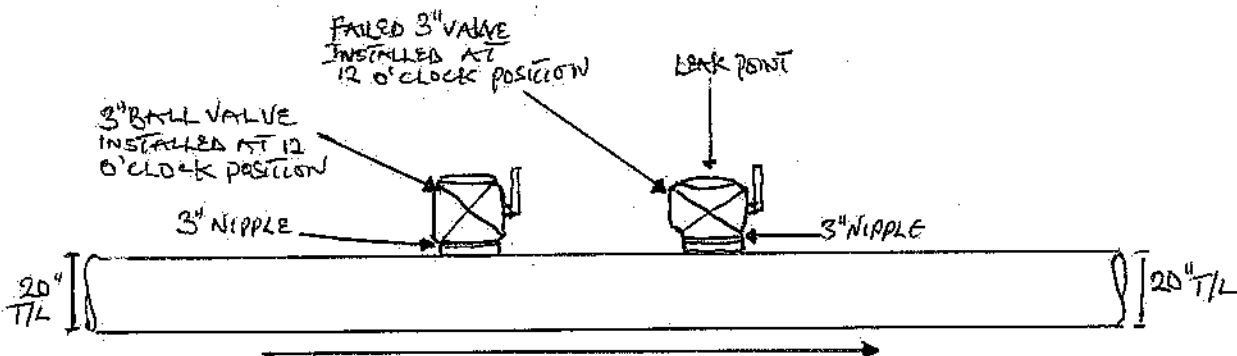
Additional observations around the spill point: THE JOINT INVESTIGATION TEAM OBSERVED TWO (2) NUMBERS OF 3" BALL VALVE ILLEGALLY INSTALLED ON THE 20" KOLOCREEK - RUMMEKPE PIPELINE AT ODAU (KM9).

SECTIONAL VIEW OF 20" KOLO CREEK-RUMMERPE (TRUNKLINE) PIPELINE AT ODAU SHOWING LEAK DUE TO 3" BALL VALVE THEE FITTING INSTALLED AT 12 O' CLOCK POSITION BY UNKNOWN PERSON(S).

RECOVERY OF SPILLED CRUDE OIL AND TEMPORARY REPAIR WORK OF THEFT POINT ON-GOING

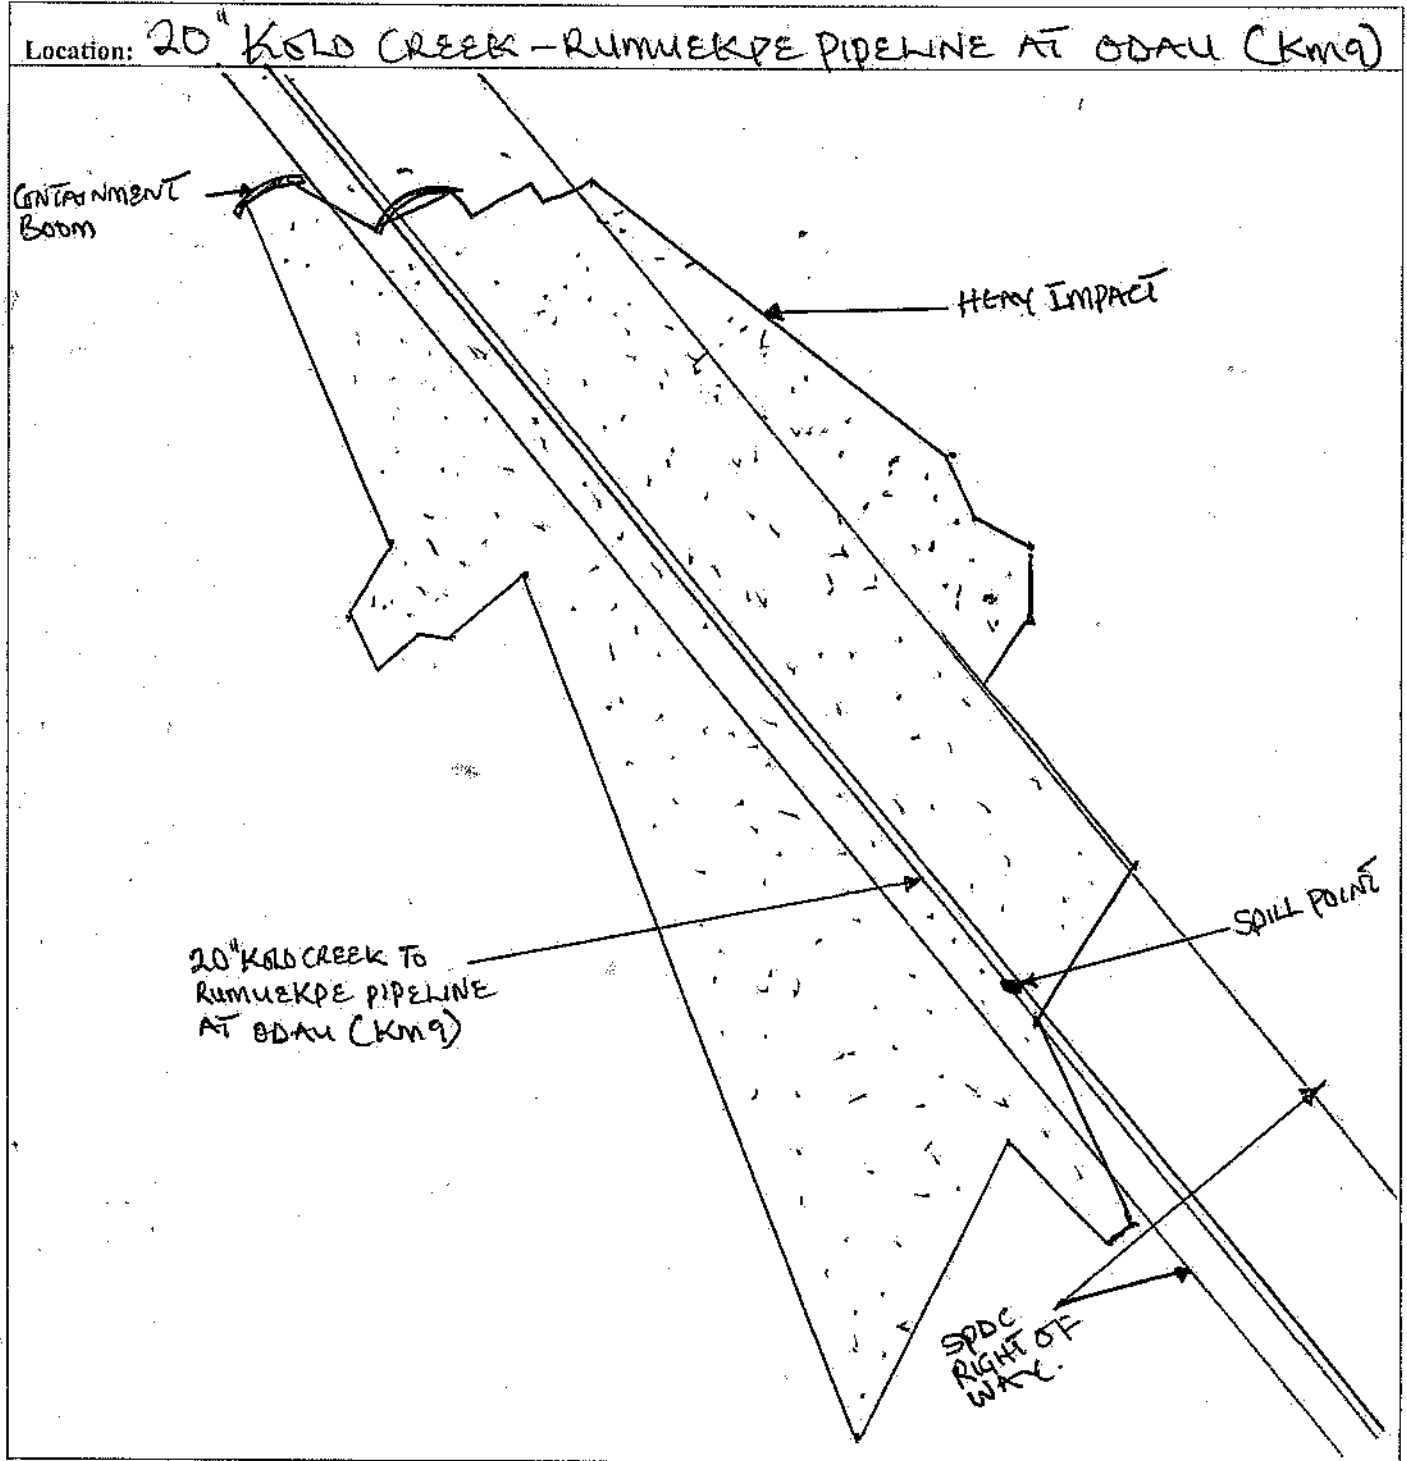
f. Appendix 1: Overview sketch of the site

20" Kolo Creek - Rumuekpe Pipeline at Odau (km9) FID. 2259160

HEAVY IMPACT

- Total calculated area of impact 3.528494 Ha
- Impact within R.O.W Yes
- Impact outside R.O.W Yes
