# JOINT INVESTIGATION REPORT

INCIDENT NO: 2270427 JIV report S/N: 0247

1. Spill incident Number: 2270427 2. Type of incident\*: OIL SPILL  
3. Name of Location 36" NKPOKU - BOMU PIPELINE  
4. Name of nearest community RUMUOHIOLO (ENEKA) 5. State: RIVERS 6. LGA OBIO/AKPOR  
7. Type of Production facility/Installation OIL PIPELINE  
8. Asset owner/District THE SHELL PETROLEUM DEVELOPMENT COMPANY OF NIGERIA LIMITED (SPDC) PIPELINE

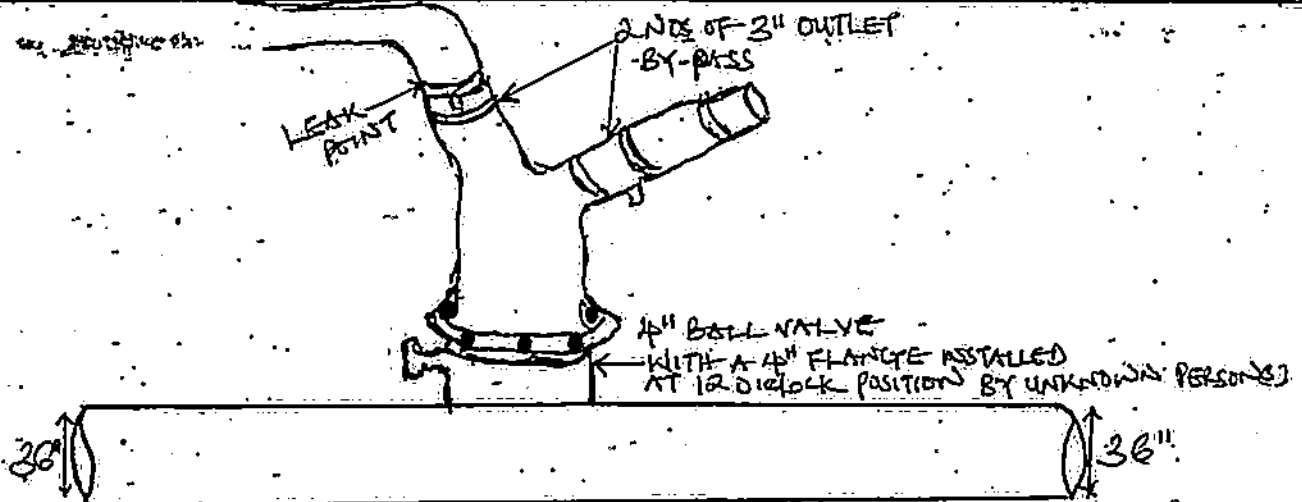
Additional observations around the spill point: SANDBAGS CONCEALING CRUDE OIL THEFT POINT WAS OBSERVED BY THE JOINT INVESTIGATION TEAM.

| <input checked="" type="checkbox"/> Failed Weld-on illegal hot tap valve | <input type="checkbox"/> Failed Clamp | <input type="checkbox"/> Missing Pipeline/Flowline |
| <input checked="" type="checkbox"/> Crude oil theft (illegal bunkering) point | <input type="checkbox"/> Saver-pit over flow | <input type="checkbox"/> Third party tampering with Clamp |

**E. GRAPHIC DESCRIPTION OF LEAK POINT** (while detailed report of the leak point should be contained in the leak report, overview sketch of the site should be added as an appendix) A SECTION OF 36" NKPOKU - BOMU PIPELINE AT ENERA CHOWING A 4" BALL VALVE WITH A 4" FLANGE REDUCE TO 2 INCHES OF 3" OUTLET BY-PASS ALL INSTALLED AT 12 O'CLOCK POSITION BY UNKNOWN PERSONS

REPAIR AND RECOVERY ACTIVITIES ARE ONGOING
