# JOINT INVESTIGATION REPORT

INCIDENT NO: 2274755 JIV report S/N: 0197

1. Spill incident Number: 2274755 2. Type of incident\*: OIL SPILL  
3. Name of Location 18" ASSA - RUMUEKPE PIPELINE  
4. Name of nearest community ECBEDA 5. State: RIVERS 6. LGA EMOHUA  
7. Type of Production facility/Installation OIL PIPELINE  
8. Asset owner/District THE SHELL PETROLEUM DEVELOPMENT COMPANY OF NIGERIA LIMITED (SPDC)/PIPELINE

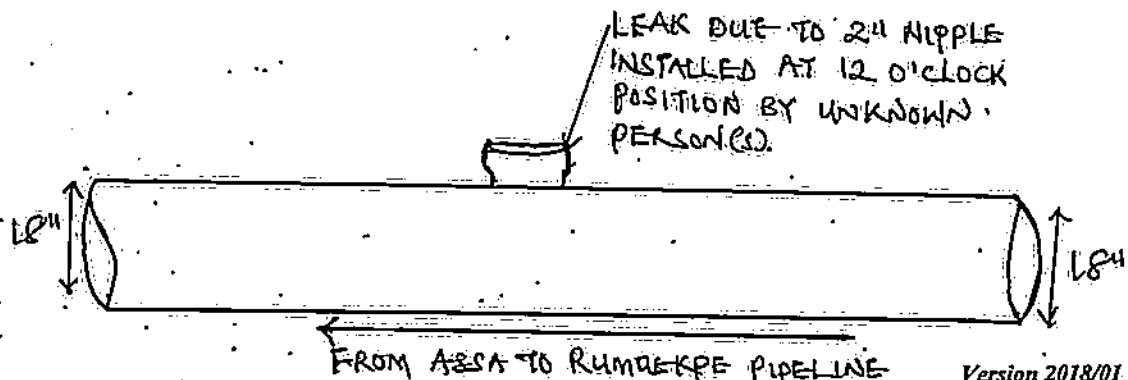
| <input checked="" type="checkbox"/> Crude oil theft (illegal bunkering) point | <input type="checkbox"/> Saver-pit over flow | <input type="checkbox"/> Third party tampering with Clamp |

- ☒ Third party interference (Sabotage ☐; crude theft ☒; Line theft ☐; Accidental 3rd party damage ☐  
☐ Operational ☐ Mystery spills ☐ Others(specify) \_\_\_\_\_

A SECTION OF 18" ASSA - RUMUEKPE PIPELINE AT EGBEA SHOWING A 2" NIPPLE INSTALLED AT 12 O'CLOCK POSITION BY UNKNOWN PERSON(S).

RECOVERY AND REPAIR ACTIVITIES ARE ONGOING

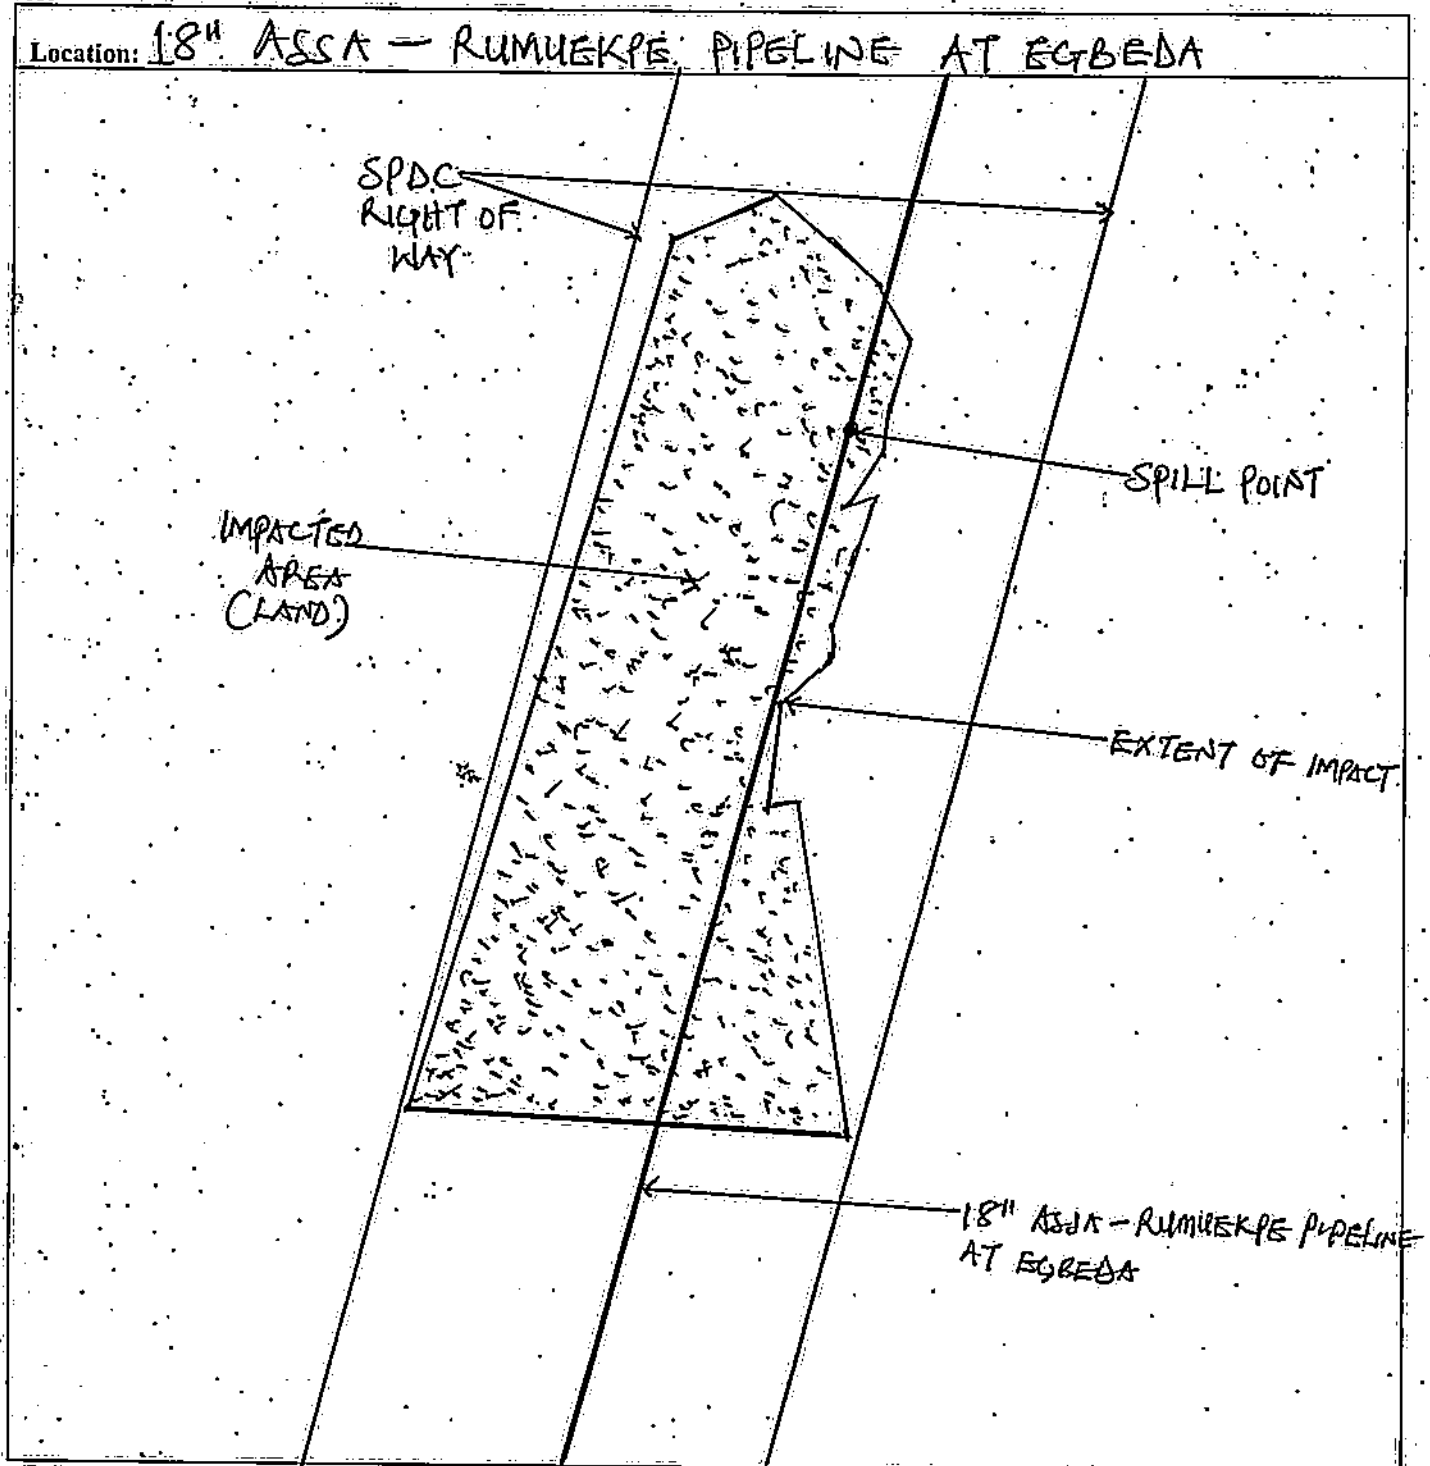
f. Appendix I: Overview sketch of the site

Additional observations around the spill point: SAND BAGS WERE OBSERVED AROUND THE SPILL POINT BY THE JOINT INVESTIGATION TEAM.
