JOINT INVESTIGATION REPORT

INCIDENT NO: 2272155 JIV report S/N: 0260

1. Spill incident Number: 2272155 2. Type of incident*: OIL SPILL
3. Name of Location: 14th OKORODIA - RUMUWERPE PIPELINE
4. Name of nearest community UULA-IKATA 5. State: RIVERS 6. LGA ATODABA - EAST
7. Type of Production facility/Installation OIL PIPELINE
8. Asset owner/District THE SHELL PETROLEUM DEVELOPMENT COMPANY OF NIGERIA LIMITED PIPELINE

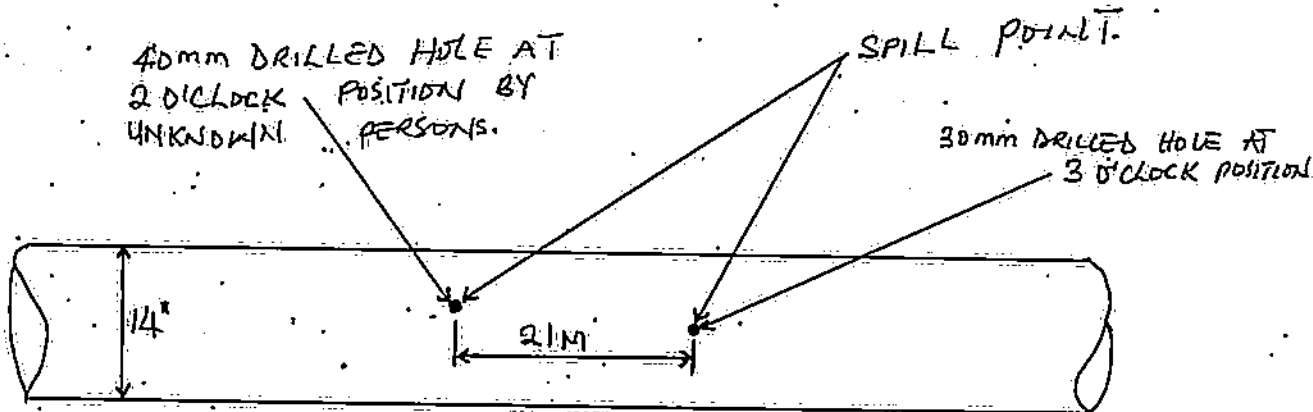
| <input checked="" type="checkbox"/> Drilled hole | <input type="checkbox"/> Hack saw cut | <input type="checkbox"/> Tear (_____) |

- Third party interference (Sabotage; crude theft; Line theft; Accidental 3rd party damage
 Operational Mystery spills Others(specify) _____

E. GRAPHIC DESCRIPTION OF LEAK POINT (while detailed report of the leak point should be contained in the leak report, overview sketch of the site should be added as an appendix 1) A SECTION OF 14" OKORDIA - RUMUWUKE PIPELINE AT ULA-IKATA SHOWING 2 NOS DRILLED HOLE AT 2 O'CLOCK AND 3 O'CLOCK POSITION BY UNKNOWN PERSONS.

CRUDE OIL RECOVERY AND REPAIR BY CLAMPING ARE ON GOING.
