# JOINT INVESTIGATION REPORT

INCIDENT NO: 2272314 JIV report S/N: 0251

1. Spill incident Number: 2272314 2. Type of incident\* OIL SPILL  
3. Name of Location 12" IMORIVER - OGALE PIPELINE  
4. Name of nearest community OWAZA 5. State: ABIA 6. LGA UKWA WEST  
7. Type of Production facility/Installation OIL PIPELINE  
8. Asset owner/District THE SHELL PETROLEUM DEVELOPMENT COMPANY  
OF NIGERIA LIMITED / PIPELINE

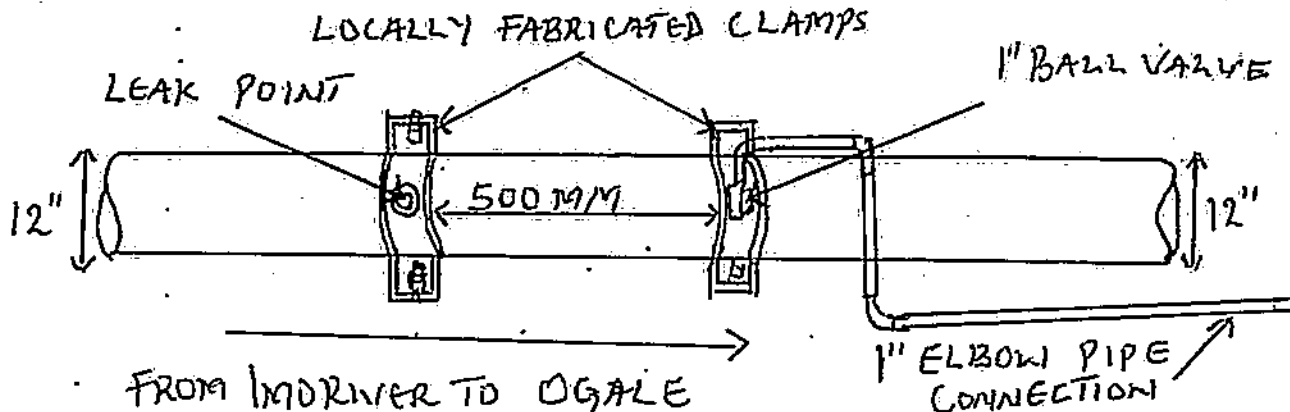
Additional observations around the spill point: THE JOINT INVESTIGATION TEAM OBSERVED TWO NUMBERS OF CRUDE OIL THEFT POINTS INSTALLED AT 12 O'CLOCK POSITIONS.

| <input checked="" type="checkbox"/> Failed Weld-on illegal hot tap valve | <input type="checkbox"/> Failed Clamp | <input type="checkbox"/> Missing Pipeline/Flowline |
| <input checked="" type="checkbox"/> Crude oil theft (illegal bunkering) point | <input type="checkbox"/> Saver-pit over flow | <input type="checkbox"/> Third party tampering with Clamp |

SECTION OF 12" IMORIVER - OGALE PIPELINE AT OWAZA SHOWING TWO NUMBERS OF CRUDE OIL THEFT POINTS INSTALLED AT 12 O'CLOCK POSITION

RECOVERY AND REPAIR ACTIVITIES ONGOING
