JOINT INVESTIGATION REPORT

INCIDENT NO: 2277004 JIV report S/N: 0254

1. Spill incident Number: 2277004 2. Type of incident*: OIL SPILL
3. Name of Location 10" DIEBU CREEK - NUNRIVER PIPELINE
4. Name of nearest community PEREMABIRI 5. State: BAYELSA 6. LGA SOUTHERN IJAW
7. Type of Production facility/Installation OIL PIPELINE
8. Asset owner/District THE SHELL PETROLEUM DEVELOPMENT COMPANY
OF NIGERIA LIMITED / PIPELINE

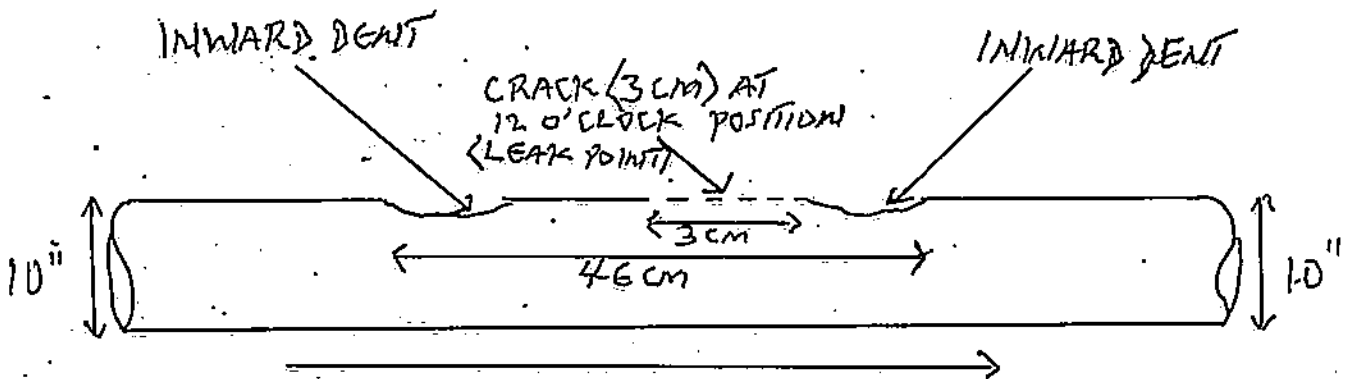
Additional observations around the spill point: THE JOINT INVESTIGATION TEAM OBSERVED INWARD DENTS AND CRACK AT 12 O'CLOCK POSITION OF 10" DIEBU CREEK - NUNRIVER PIPELINE.

| <input type="checkbox"/> Corrosion | <input checked="" type="checkbox"/> Others(specify) <u>CRACK (3CM) AT 12 O'CLOCK POSITION</u> | |

SECTION OF 10" DIEBU CREEK - NUNRIVER PIPELINE AT PEREMABIRI SHOWING INWARD DENTS AND CRACK AT 12 O'CLOCK POSITION.

REPAIR WORK ACTIVITIES ONGOING
