JOINT INVESTIGATION REPORT

INCIDENT NO: 2276060 JIV report S/N: 0256

1. Spill incident Number: 2276060 2. Type of incident*: OIL SPILL
3. Name of Location 20" KOLD CREEK - RUMUEKPE PIPELINE RISER
4. Name of nearest community RUMUEKPE 5. State: RIVERS 6. LGA EMOHUA
7. Type of Production facility/Installation OIL PIPELINE
8. Asset owner/District THE SHELL PETROLEUM DEVELOPMENT COMPANY OF NIGERIA LTD (S.P.D.C) / PIPELINE

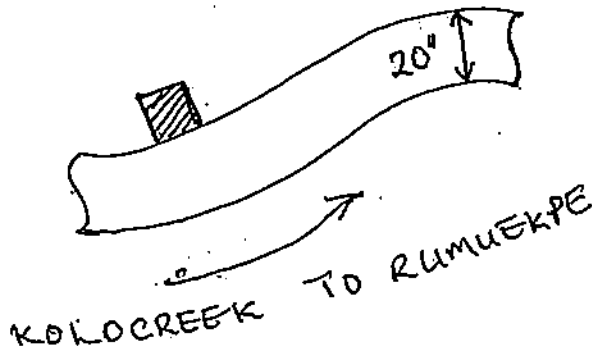
| <input checked="" type="checkbox"/> Crude oil theft (illegal bunkering) point | <input type="checkbox"/> Saver-pit over flow | <input type="checkbox"/> Third party tampering with Clamp |

E. GRAPHIC DESCRIPTION OF LEAK POINT (while detailed report of the leak point should be contained in the leak report, overview sketch of the site should be added as an appendix 1) A SECTION OF 20" KOLOCREEK - RUMUEKPE PIPELINE RISER AT RUEKPE SHOWING CONCRETE CAST ON A CRUDE OIL THEFT POINT FROM PREVIOUS INCIDENT,

REPAIR BY CLAMPING OR
 SECTIONAL REPLACEMENT
