JOINT INVESTIGATION REPORT

INCIDENT NO: 2270380 JIV report S/N:0215

1. Spill incident Number: 2270380 2. Type of incident*: OIL SPILL
3. Name of Location 28" BOMU - BONNY TRANS NIGER PIPELINE
4. Name of nearest community (PATRICK WATER SIDE) BODO WEST 5. State: RIVERS 6. LGA (GOKANA)
7. Type of Production facility/Installation OIL PIPELINE
8. Asset owner/District THE SHELL PETROLEUM DEVELOPMENT COMPANY OF NIGERIA LIMITED PIPELINE

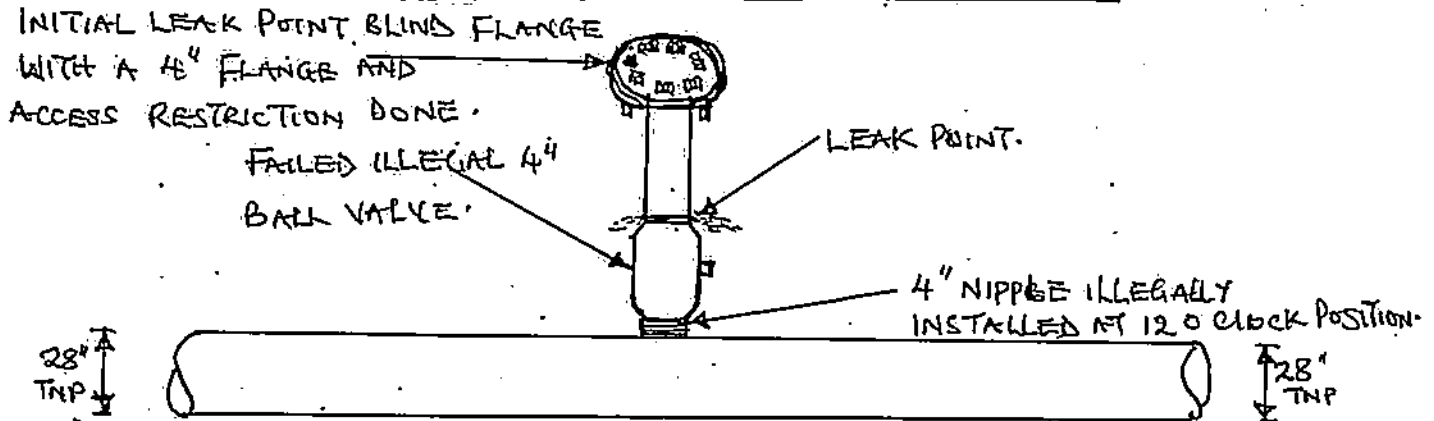
SECTIONAL VIEW OF 28" BOMU - BONNY TRANS NIGER PIPELINE

Additional observations around the spill point: THE SPILL INCIDENT POINT IS FROM EARLIER CRUDE THEFT POINT WITH INCIDENT NUMBER 2283363 FOR WHICH JIV WAS CONDUCTED ON THE 16TH JANUARY, 2019. THE THEFT POINT OF THE ILLEGAL ATTACHMENT FAILED; WHILE EFFORT WAS BEING MADE TO REPAIR THE LINE.

| <input checked="" type="checkbox"/> Failed Weld-on illegal hot tap valve | <input type="checkbox"/> Failed Clamp | <input type="checkbox"/> Missing Pipeline/Flowline |

SHOWING:- ONE FAILED ILLEGAL 4" THEFT FITTING INSTALLED AT 12 O'CLOCK POSITION BY UNKNOWN PERSON(S)

RECOVERY WORK AND REPAIR WORK BY CLAMPING COMPLETED

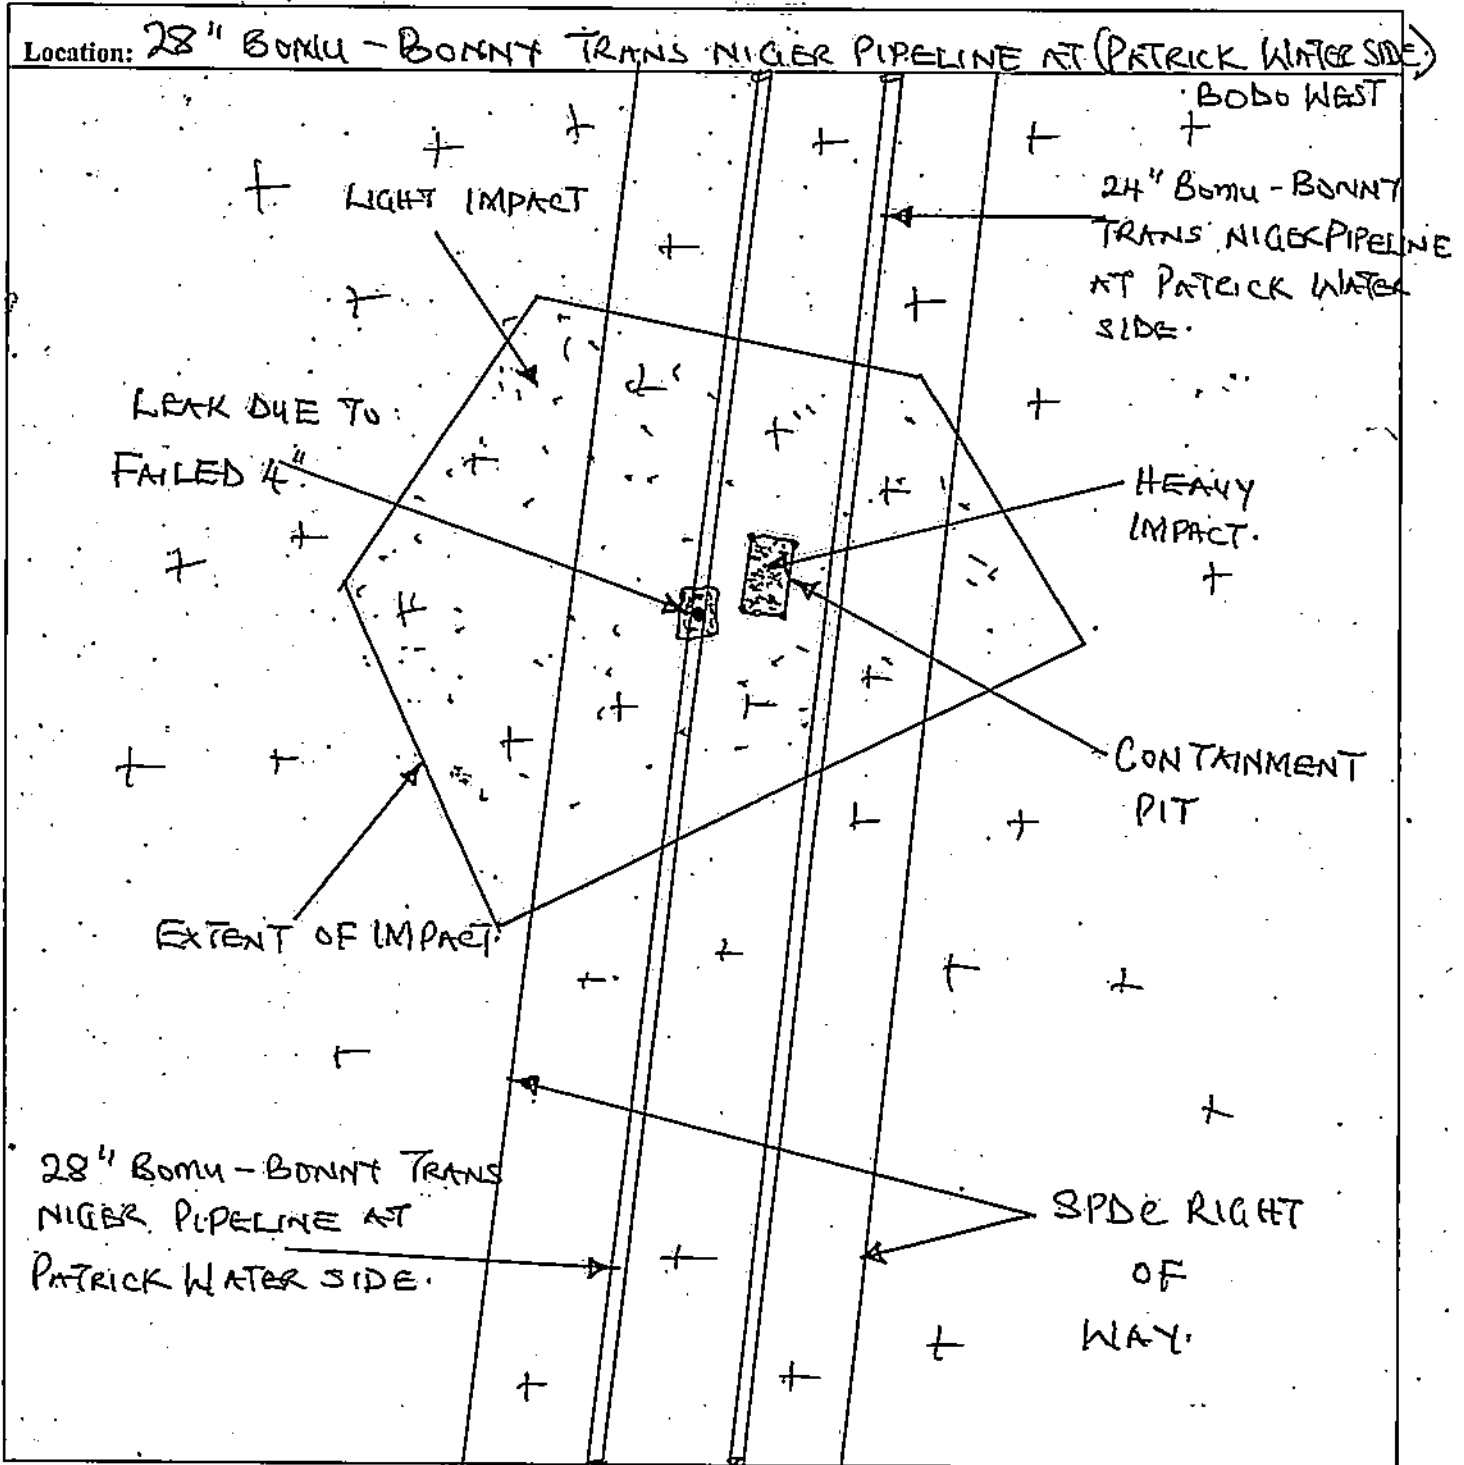
f. Appendix 1: Overview sketch of the site

- Total calculated area of impact 0.36 HA
- Impact within R.O.W YES
- Impact outside R.O.W YES
