# JOINT INVESTIGATION REPORT

INCIDENT NO: 2240479 JIV report S/N: 0196

1. Spill incident Number: 2240479 2. Type of incident\*: OIL SPILL  
3. Name of Location 10" DEEBU CREEK-NUN RIVER (DELIVERY LINE) PIPELINE.  
4. Name of nearest community DIPOROMA 5. State: BAYELSA 6. LGA SOUTHERN-ITAM  
7. Type of Production facility/Installation OIL PIPELINE  
8. Asset owner/District THE SHELL PETROLEUM DEVELOPMENT COMPANY OF NIGERIA LIMITED/PIPELINE.

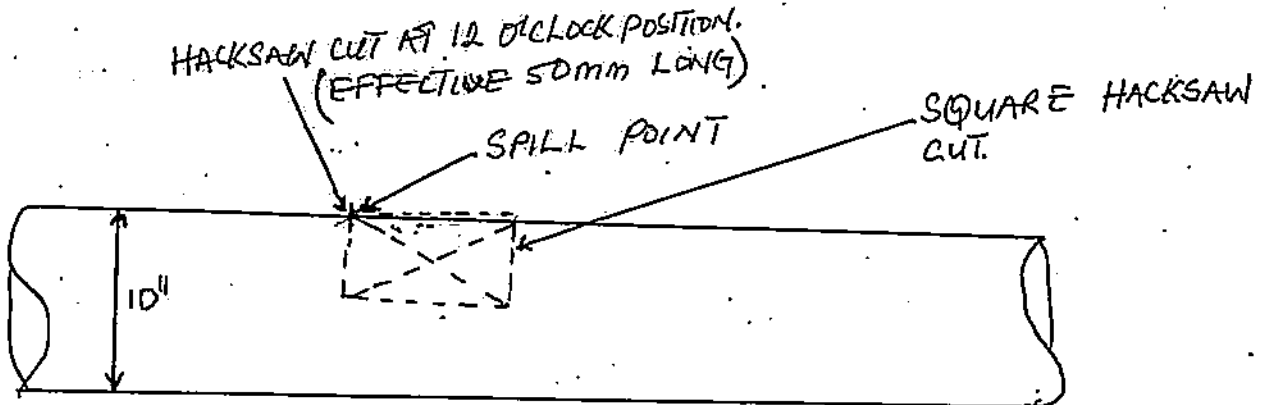
**E. GRAPHIC DESCRIPTION OF LEAK POINT** (while detailed report of the leak point should be contained in the leak report, overview sketch of the site should be added as an appendix 1) A SECTION OF 16" DEBU CREEK - NUN RIVER (DELIVERY LINE) PIPELINE AT OPODMA SHOWING A HACKSAW CUT AT 12 O'CLOCK POSITION BY UNKNOWN PERSONS.
