JOINT INVESTIGATION REPORT

INCIDENT NO: 2242663 JIV report S/N: 0238

1. Spill incident Number: 2242663 2. Type of incident* OIL SPILL
3. Name of Location 16" NUN RIVER - KULO CREEK PIPELINE
4. Name of nearest community AGUOBIRI 5. State: BAYELSA 6. LGA SOUTHERN-IJAW
7. Type of Production facility/Installation OIL PIPELINE
8. Asset owner/District THE SHELL PETROLEUM DEVELOPMENT COMPANY OF NIGERIA LIMITED/PIPELINE.

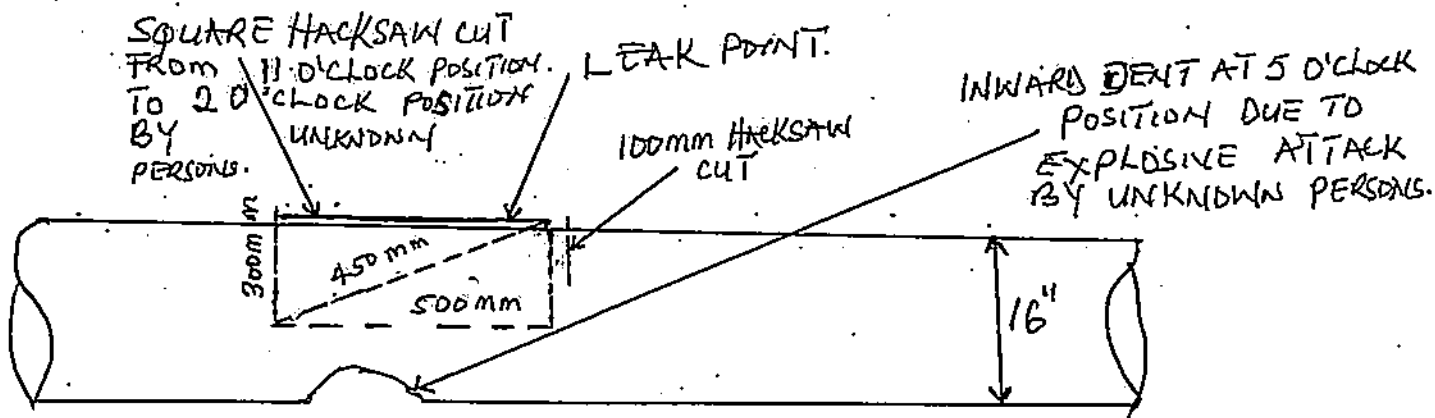
Additional observations around the spill point: THE JOINT INVESTIGATION TEAM OBSERVED DAMAGED POLYKENE TAPE COATING, A SQUARE SHAPED HACKSAW CUT WITH A DIAGONAL CUT INSIDE THE SQUARE AND INWARD DENT AT 5 O'CLOCK POSITION DUE TO EXPLOSIVE ATTACK BY UNKNOWN PERSONS.

E. GRAPHIC DESCRIPTION OF LEAK POINT (while detailed report of the leak point should be contained in the leak report, overview sketch of the site should be added as an appendix 1) A SECTION OF 16" NUN RIVER - KOLD CREEK PIPELINE AT AGUDIBI SHOWING SQUARE HACKSAW CUT AND INWARD DENT AT 5 O'CLOCK POSITION BY UNKNOWN PERSONS.

REPAIR BY SECTIONAL REPLACEMENT AND CRUISE OIL RECOVERY ARE ONGOING.
