# JOINT INVESTIGATION REPORT

INCIDENT NO: 2241888 JIV report S/N: 0216

1. Spill incident Number: 2241888 2. Type of incident\* OIL SPILL  
3. Name of Location 12" OGUTA - EGBEMA DELIVERY LINE  
4. Name of nearest community UMUNKWU 5. State: IMD 6. LGA OGUTA  
7. Type of Production facility/Installation OIL PIPELINE  
8. Asset owner/District THE SHELL PETROLEUM DEVELOPMENT COMPANY OF NIGERIA LTD (SPDC) / PIPELINE

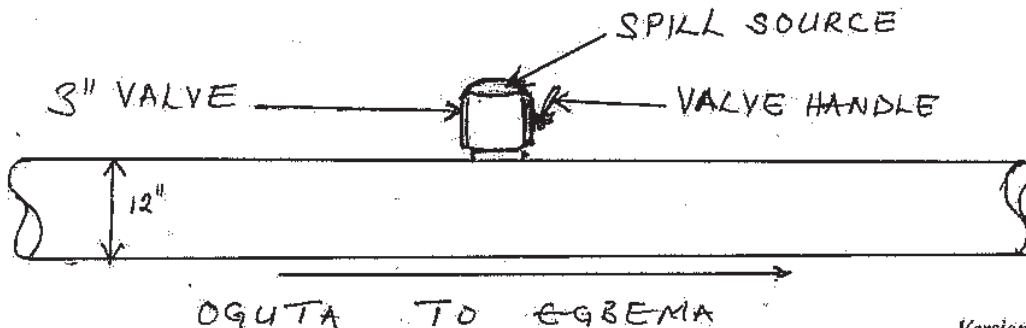
**E. GRAPHIC DESCRIPTION OF LEAK POINT** (while detailed report of the leak point should be contained in the leak report, overview sketch of the site should be added as an appendix !)

Additional observations around the spill point: THE JOINT INVESTIGATION TEAM OBSERVED A 3" VALVE CRUDE THEFT POINT INSTALLED AT 12 O'CLOCK POSITION, BY UNKNOWN PERSONS.

A SECTION OF 12" OGUTA-EGBEMA DELIVERY LINE AT UMUNKWU-OGUTA SHOWING 3" VALVE CRUDE THEFT POINT INSTALLED AT 12 O'CLOCK POSITION BY UNKNOWN PERSONS.

REPAIR BY CLAMPING
