# JOINT INVESTIGATION REPORT

INCIDENT NO: 2252623 JIV report S/N: 0222

1. Spill incident Number: 2252623      2. Type of incident\* OIL SPILL  
 3. Name of Location 16" EGBEMA - ASSA PIPELINE  
 4. Name of nearest community UMUDIKE      5. State: IND      6. LGA OHAJI | EGBEMA  
 7. Type of Production facility/Installation OIL PIPELINE  
 8. Asset owner/District THE SHELL PETROLEUM DEVELOPMENT COMPANY OF NIGERIA LIMITED | PIPELINE.

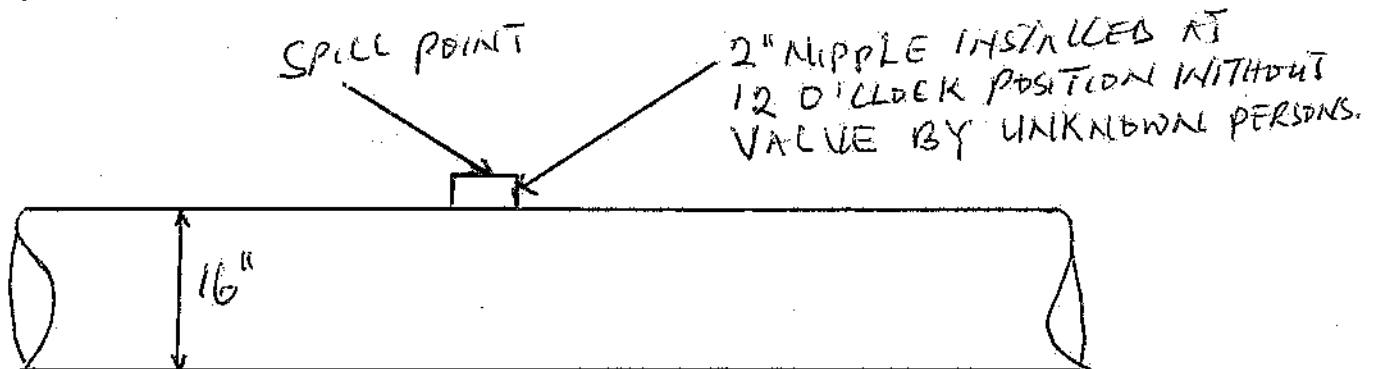
Additional observations around the spill point: THE JOINT INVESTIGATION TEAM OBSERVED SAND BAGS WITHIN THE LEAK POINT AREA.

| <input checked="" type="checkbox"/> Crude oil theft (illegal bunkering) point | <input type="checkbox"/> Saver-pit over flow | <input type="checkbox"/> Third party tampering with Clamp |

**E. GRAPHIC DESCRIPTION OF LEAK POINT** (while detailed report of the leak point should be contained in the leak report, overview sketch of the site should be added as an appendix 1) A SECTION OF 16" EGBEMA - ASSA PIPELINE AT UNJUDIKE SHOWING A 2" NIPPLE INSTALLED AT 12 O'CLOCK POSITION BY UNKNOWN PERSONS.

CRUISE OIL RECOVERY AND PIPELINE REPAIR  
BY CLAMPING ARE ONGOING.
