JOINT INVESTIGATION REPORT

INCIDENT NO: 2252622 JIV report S/N: 0207

1. Spill incident Number: 2252622 2. Type of incident*: OIL SPILL
3. Name of Location 6" SOKU - SOKU DELIVERY LINE
4. Name of nearest community SOKU 5. State: RIVERS 6. LGA AKUKUTORU
7. Type of Production facility/Installation DELIVERY LINE
8. Asset owner/District THE SHELL PETROLEUM DEVELOPMENT COMPANY OF NIGERIA LTD (SPDC) PIPELINE

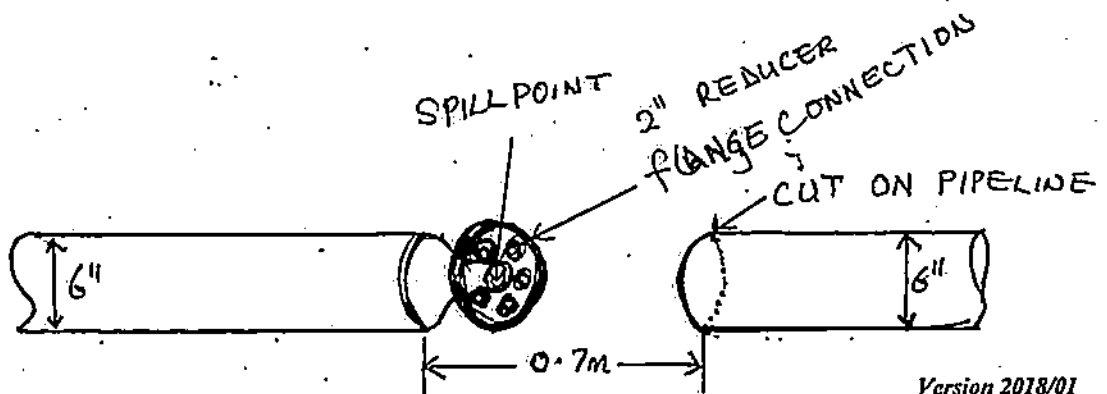
E. GRAPHIC DESCRIPTION OF LEAK POINT (while detailed report of the leak point should be contained in the leak report, overview sketch of the site should be added as an appendix 1) A SECTION OF 6" SOKU - SOKU DELIVERY LINE AT SOKU SHOWING 0.7m MISSING DELIVERY LINE AND 2" REDUCER FLANGE CONNECTIONS INSTALLED AT AN END OF THE CUT OFF DELIVERY LINE BY UNKNOWN PERSONS,

REPAIR BY CLAMPING
