# JOINT INVESTIGATION REPORT

INCIDENT NO: 2217796 JIV report S/N: 0224

1. Spill incident Number: 2217796 2. Type of incident\*: OIL SPILL  
3. Name of Location: 12" IMO RIVER - OGALE PIPELINE  
4. Name of nearest community: KOMKOM 5. State: RIVERS 6. LGA: OYIGBO  
7. Type of Production facility/Installation: OIL PIPELINE  
8. Asset owner/District: THE SHELL PETROLEUM DEVELOPMENT COMPANY OF NIGERIA LIMITED (SPDC) / PIPELINE

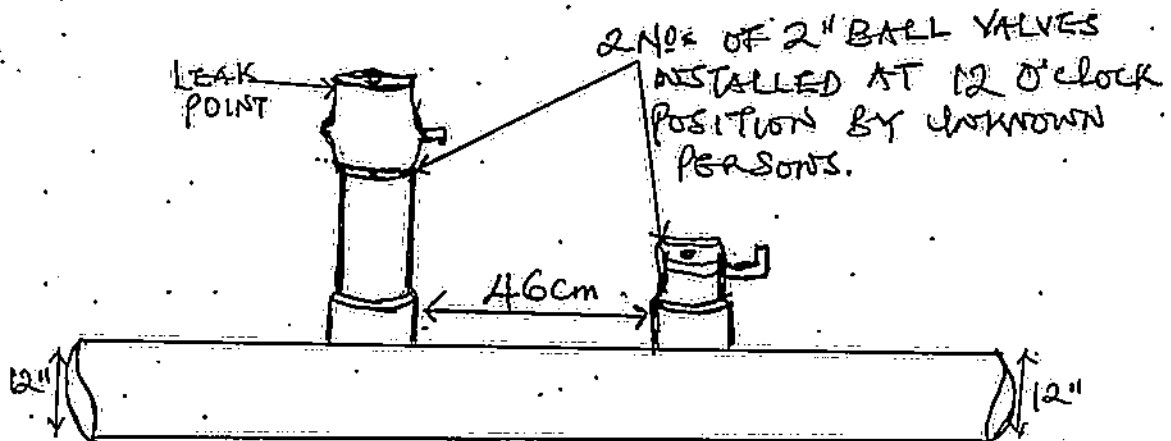
IMO RIVER TO OGALE PIPELINE

| <input checked="" type="checkbox"/> Complete Rupture | <input type="checkbox"/> Inward dent | <input type="checkbox"/> Well head tampering |
| <input checked="" type="checkbox"/> Crude oil theft (illegal bunkering) point | <input type="checkbox"/> Saver-pit over flow | <input type="checkbox"/> Third party tampering with Clamp |

SECTIONAL VIEW OF 12" IMO RIVER - OGALE PIPELINE AT KOMKOM SHOWING TWO(2) NO OF 2" BALL VALVES INSTALLED AT 12 O'CLOCK POSITION BY UNKNOWN PERSONS.

RECOVERY AND REPAIR ACTIVITIES ARE ONGOING
