JOINT INVESTIGATION REPORT

INCIDENT NO: 2255965 JIV report S/N: 0230

1. Spill incident Number: 2255965 2. Type of incident*: OIL SPILL
3. Name of Location: 12" IMO RIVER - OGALE PIPELINE
IGIRI-UKWU
4. Name of nearest community: (OWAZA) 5. State: ABIA 6. LGA: UKWA - WEST
7. Type of Production facility/Installation: OIL PIPELINE
8. Asset owner/District: THE SHELL PETROLEUM DEVELOPMENT COMPANY
OF NIGERIA LIMITED / PIPELINE

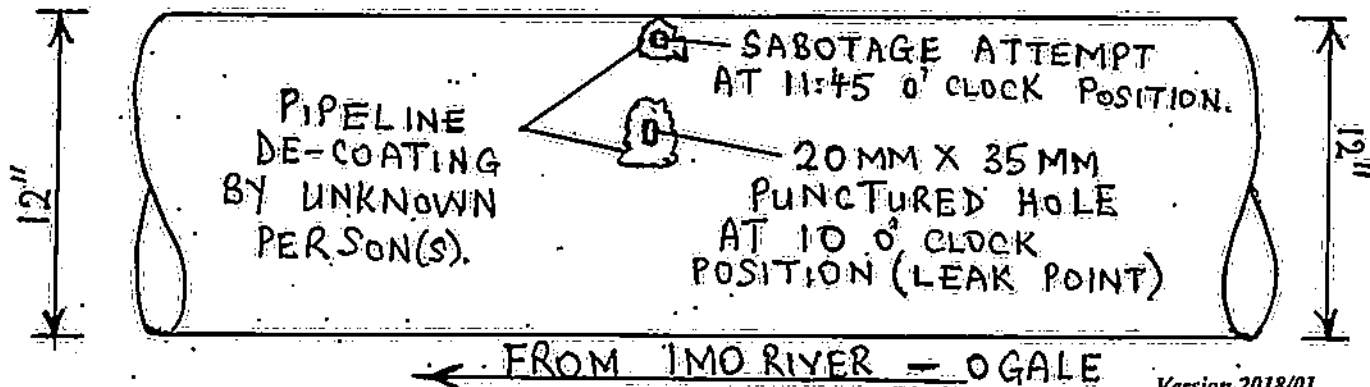
SECTION OF 12" IMO RIVER - OGALE PIPELINE AT IGIRI-UKWU (OWAZA) SHOWING LEAK POINT.

Additional observations around the spill point: A CLUSTER OF FLOW LINES WAS OBSERVED AROUND THE 12" PIPELINE ON WHICH THE SPILL POINT WAS NOTICED. ILLEGAL PIPELINE DE-COATING WERE OBSERVED AROUND BOTH THE SPILL POINT AND A SABOTAGE ATTEMPT ON THE PIPELINE.

| <input type="checkbox"/> Corrosion | <input checked="" type="checkbox"/> Others (specify) <u>PUNCTURED HOLE</u> | |
