JOINT INVESTIGATION REPORT

INCIDENT NO: 2254193 JIV report S/N: 0228

1. Spill incident Number: 2254193 2. Type of incident* OIL SPILL
3. Name of Location 12" IMB RWER - OGALE (TRUNKLINE) PIPELINE
4. Name of nearest community OGALE 5. State: RWERS 6. LGA ELEME
7. Type of Production facility/Installation OIL PIPELINE
8. Asset owner/District THE SHELL PETROLEUM DEVELOPMENT COMPANY OF NIGERIA LIMITED/ PIPELINE

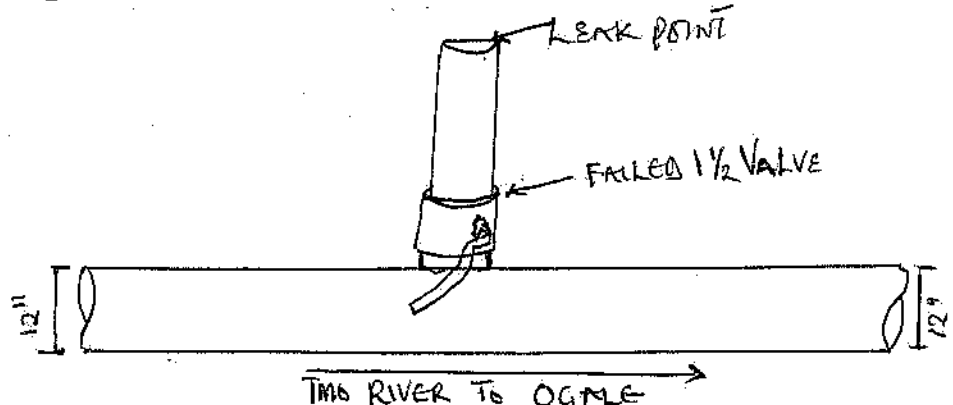
| <input checked="" type="checkbox"/> Failed Weld-on illegal hot tap valve | <input type="checkbox"/> Failed Clamp | <input type="checkbox"/> Missing Pipeline/Flowline |
| <input checked="" type="checkbox"/> Crude oil theft (illegal bunkering) point | <input type="checkbox"/> Saver-pit over flow | <input type="checkbox"/> Third party tampering with Clamp |

SECTIONAL VIEW OF 12" IMO RIVER - OGALE (TRUNKLINE) PIPELINE AT OGALE SHOWING 1 1/2 CRUDE OIL TIGHT POINT INSTALLED AT 12 O' CLOCK POSITION BY UNKNOWN PERSON(S).

REPAIR By CLAMPING

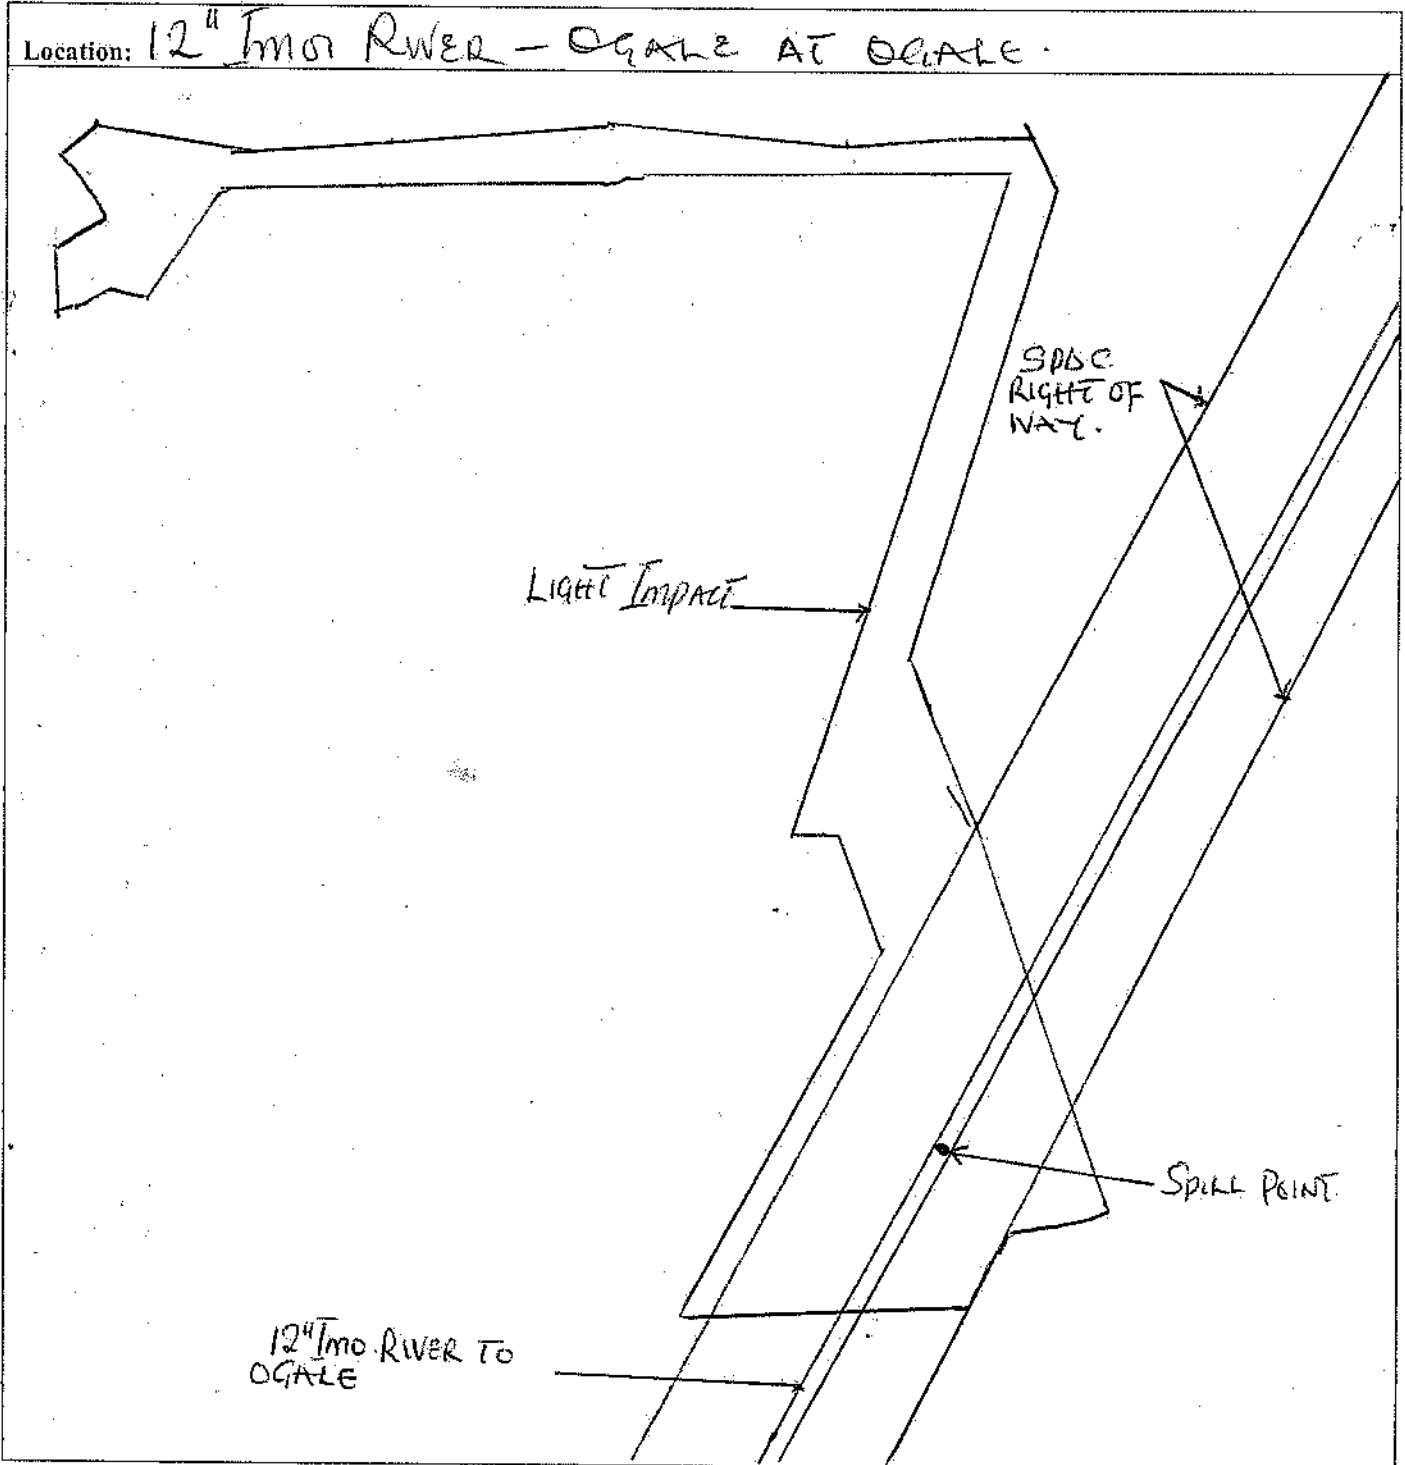
f. Appendix 1: Overview sketch of the site

- Total calculated area of impact 1.03 HA
- Impact within R.O.W YES
- Impact outside R.O.W YES
