JOINT INVESTIGATION REPORT

INCIDENT NO: 2283363 JIV report S/N: 0243

1. Spill incident Number: 2283363 2. Type of incident*: OIL SPILL
3. Name of Location 28" BOMU - BONNY TRANS NIGER PIPELINE
4. Name of nearest community PATRICK WATER SIDE 5. State: RIVERS 6. LGA GOKANA
7. Type of Production facility/Installation OIL PIPELINE
8. Asset owner/District THE SHELL PETROLEUM DEVELOPMENT COMPANY OF NIGERIA LIMITED PIPELINE

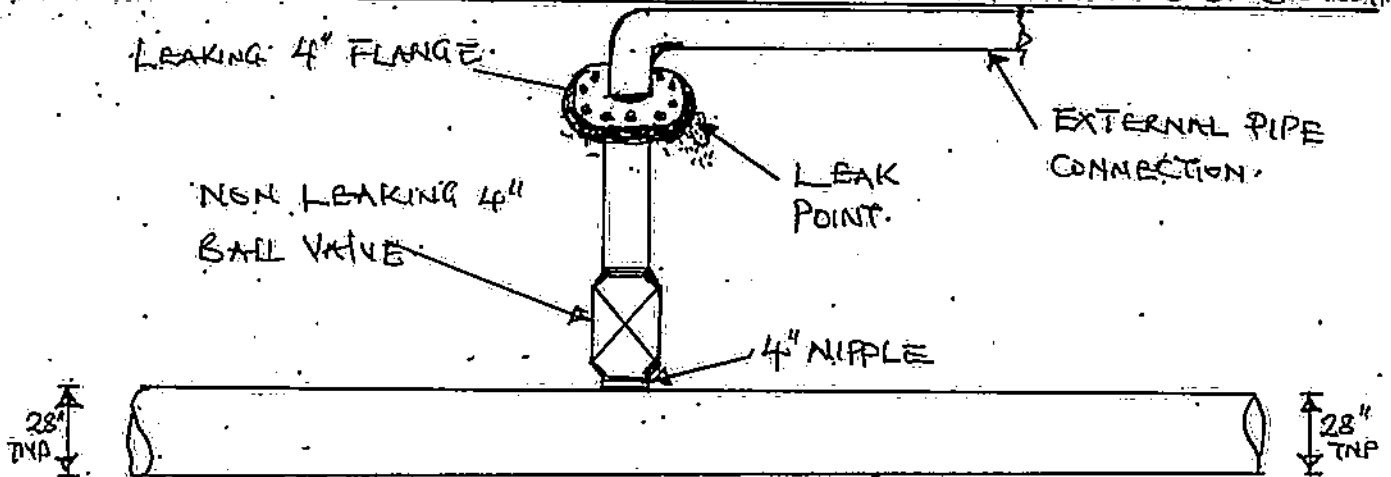
| <input checked="" type="checkbox"/> Failed Weld-on illegal hot tap valve | <input type="checkbox"/> Failed Clamp | <input type="checkbox"/> Missing Pipeline/Flowline |
| <input checked="" type="checkbox"/> Crude oil theft (illegal bunkering) point | <input type="checkbox"/> Saver-pit over flow | <input type="checkbox"/> Third party tampering with Clamp |

SECTIONAL VIEW OF 28" BOMU - BONNY TRANS NIGER PIPELINE AT PWS
SHOWING: ONE (1) FAILED 4" THEFT FITTING INSTALLED AT 12'O CLOCK POSITION.

TEMPORARY REPAIR BY BLIND FLANGING ON-GOING
