# JOINT INVESTIGATION REPORT

INCIDENT NO: 2283347 ~~2234923~~ JIV report S/N: 0214

1. Spill incident Number: 2283347 ~~2234923~~ 2. Type of incident\*: OIL SPILL (CRUDE THEFT POINT)
3. Name of Location: 12" MD. RIVER 2 - OGALE PIPELINE
4. Name of nearest community: ISI-ETILOHA  
OWAZA 5. State: ABIA 6. LGA UKWA - WEST
7. Type of Production facility/Installation: OIL PIPELINE
8. Asset owner/District: THE SHELL PETROLEUM DEVELOPMENT COMPANY OF NIGERIA LIMITED / PIPELINE

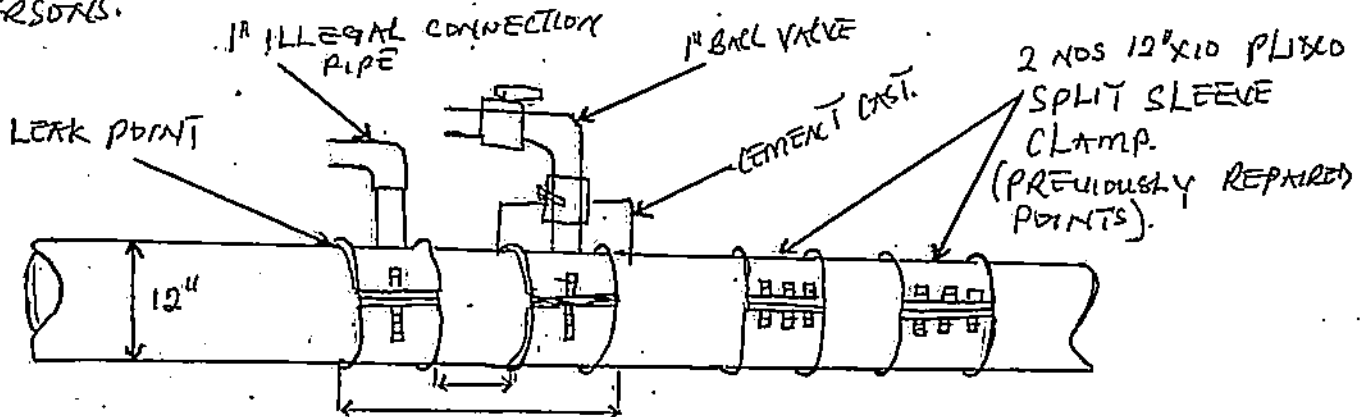
Additional observations around the spill point: THE JOINT INVESTIGATION TEAM OBSERVED CEMENT CAST AT THE BASE OF 1 MD 1" BALL VALVE ILLEGAL CONNECTION AND 2 NOS PREVIOUSLY CLAMPED POINTS.

**E. GRAPHIC DESCRIPTION OF LEAK POINT** (while detailed report of the leak point should be contained in the leak report, overview sketch of the site should be added as an appendix 1) A SECTION OF 12" INDI RIVER 2 - OGALÉ PIPELINE AT ISI-ETIIOHA - DWAZA SHOWING 2 NOS 1" ILLEGAL CONNECTION PIPES INSTALLED ON A LOCALLY FABRICATED CLAMP AT 12 O'CLOCK POSITION BY UNKNOWN PERSONS.

REPAIR BY CLAMPING ONGOING.
