# JOINT INVESTIGATION REPORT

INCIDENT NO: 2283288 ~~2212848~~ JIV report S/N: 0190

3. Name of Location: 28<sup>th</sup> BOMU - BONNY PIPELINE

8. Asset owner/District THE SHELL PETROLEUM DEVELOPMENT COMPANY OF NIGERIA LIMITED / PIPELINE

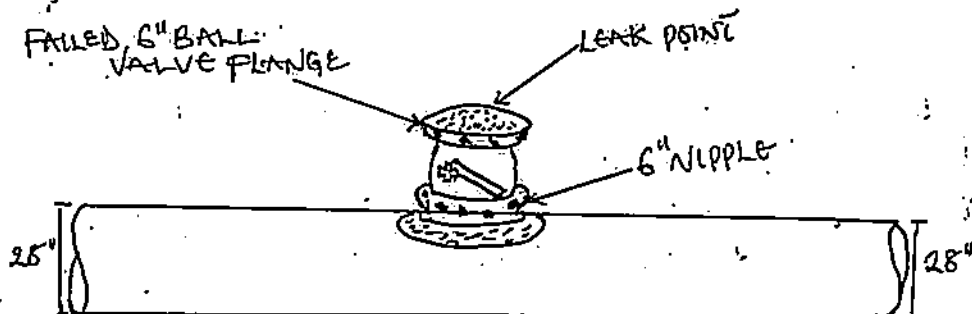
| <input checked="" type="checkbox"/> Failed Weld-on illegal hot tap valve | <input type="checkbox"/> Failed Clamp | <input type="checkbox"/> Missing Pipeline/Flowline |
| <input checked="" type="checkbox"/> Crude oil theft (illegal bunkering) point | <input type="checkbox"/> Saver-pit over flow | <input type="checkbox"/> Third party tampering with Clamp |

SECTIONAL VIEW OF 28" BOMU - BONNY PIPELINE AT ONOKIRI  
SHOWING FAILED 6" WELD-ON ILLEGAL HOT TAP VALVE INSTALLED  
AT 12 O' CLOCK POSITION BY UNKNOWN PERSON(S)...

TEMPORARY REPAIR BY BLIND FLANGING THE  
THEFT POINT ONGOING.

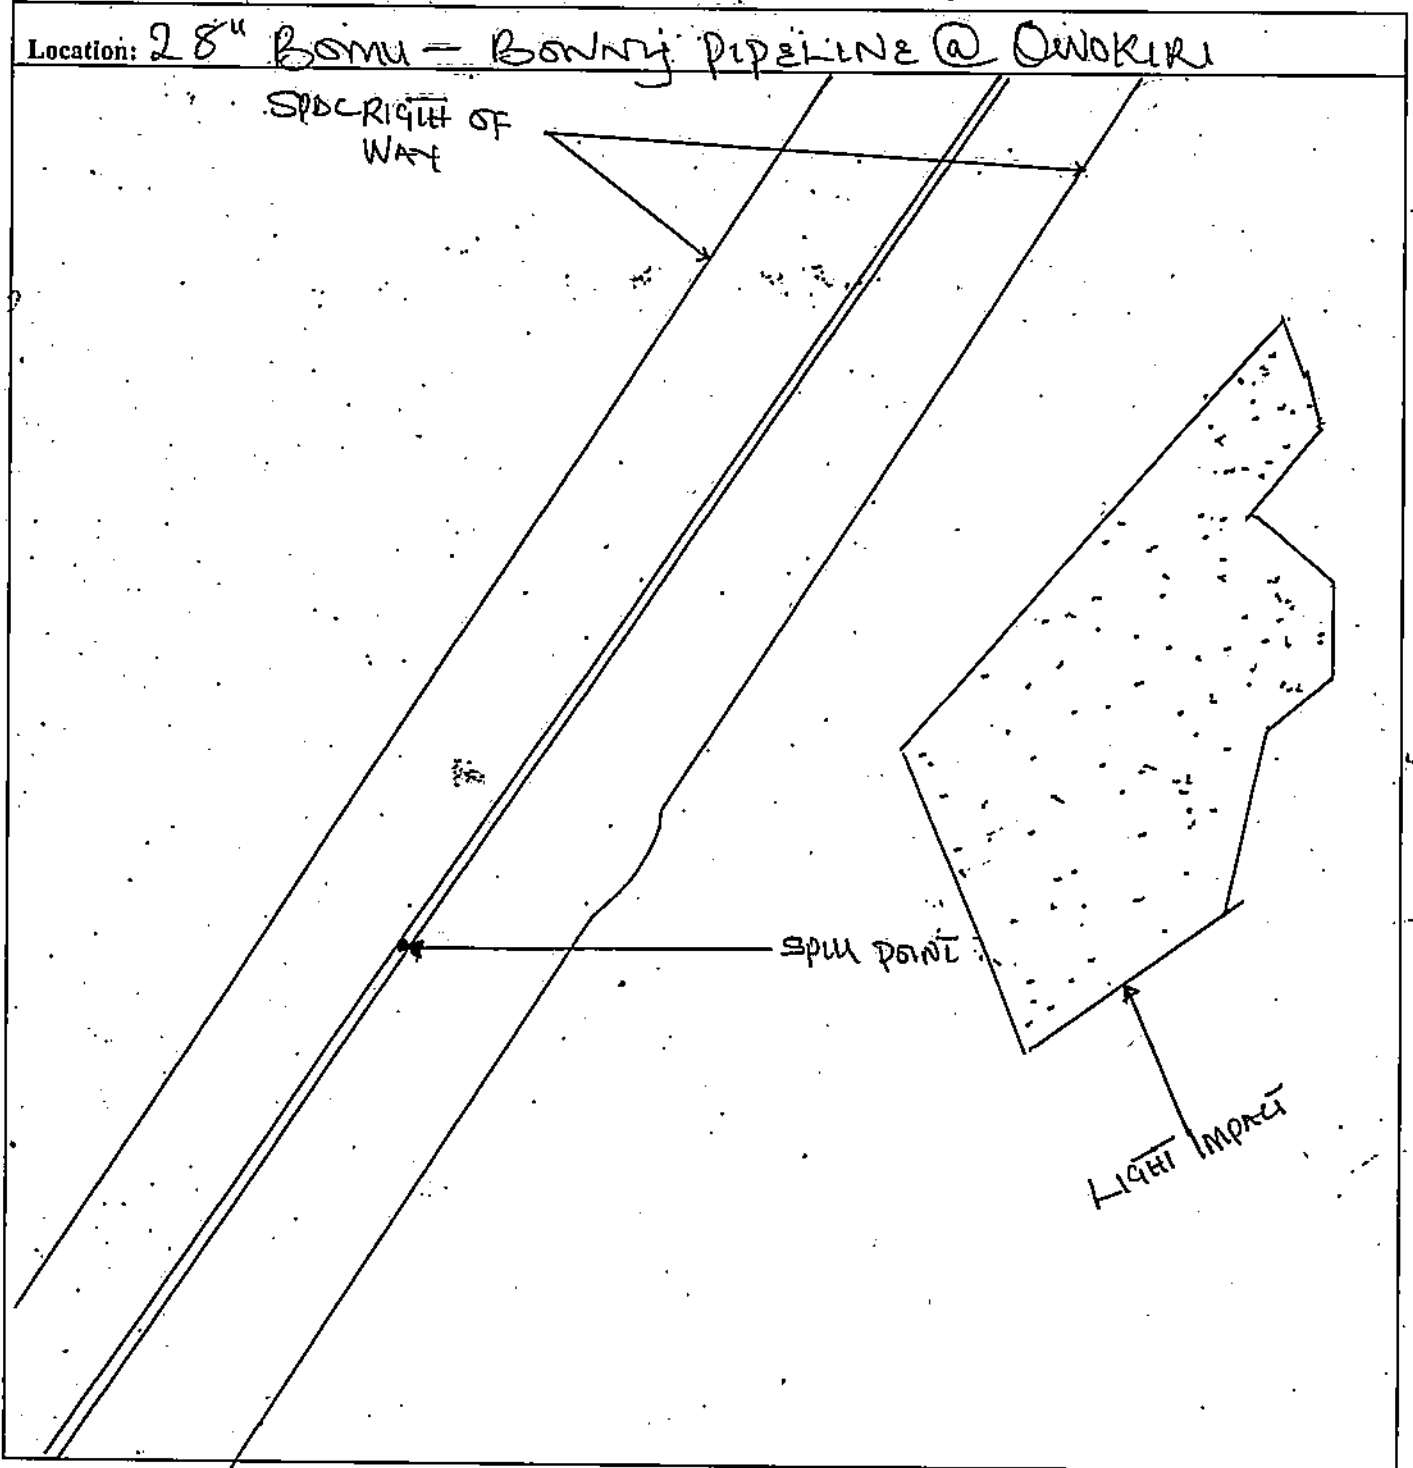
f. Appendix 1: Overview sketch of the site

Additional observations around the spill point: THE JOINT INVESTIGATION TEAM OBSERVED PLANKS AROUND THE SPILL POINT.
