JOINT INVESTIGATION REPORT

INCIDENT NO: 2283270 JIV report S/N: 0245

1. Spill incident Number: 2283270 2. Type of incident*: OIL SPILL
3. Name of Location 28" BONU - BONNY TRANS NIGER PIPELINE
4. Name of nearest community PATRICK WATER SIDE 5. State: RIVERS 6. LGA GOKANA
7. Type of Production facility/Installation OIL PIPELINE
8. Asset owner/District THE SHELL PETROLEUM DEVELOPMENT COMPANY OF NIGERIA LIMITED PIPELINE

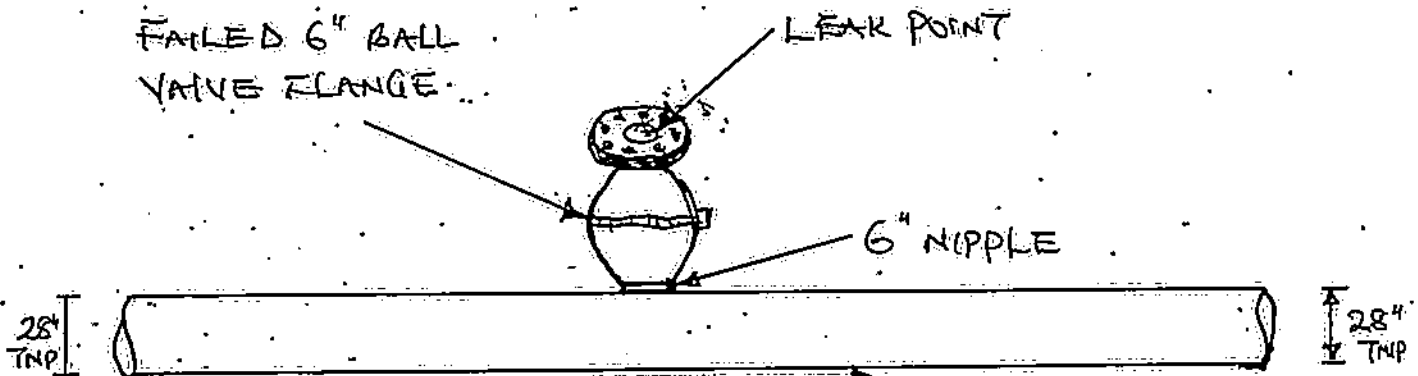
SECTIONAL VIEW OF 28" BONNU - BONNY TRANS NIGER PIPELINE AT AHS

| <input checked="" type="checkbox"/> Failed Weld-on illegal hot tap valve | <input type="checkbox"/> Failed Clamp | <input type="checkbox"/> Missing Pipeline/Flowline |
| <input checked="" type="checkbox"/> Crude oil theft (illegal bunkering) point | <input type="checkbox"/> Saver-pit over flow | <input type="checkbox"/> Third party tampering with Clamp |

SHOWING: - ONE SIX (6") FAILED BALL VALVE INSTALLED AT 12 O'CLOCK POSITION.

TEMPORARY REPAIR BY BLIND FLANGING COMPLETED
