JOINT INVESTIGATION REPORT

INCIDENT NO: 2405092 JIV report S/N: 1030057

1. Fountain Incident Number: 2405092 2. Type of incident* OIL SPILL
3. Name of Location 18" ASSA - RUMUENKPE PIPELINE
4. Name of nearest community EGBEDA 5. State: RIVERS 6. LGA EMOHUA
7. Type of Production facility/Installation OIL PIPELINE
8. Asset owner/District THE SHELL PETROLEUM DEVELOPMENT COMPANY OF NIGERIA LIMITED (SPDC)

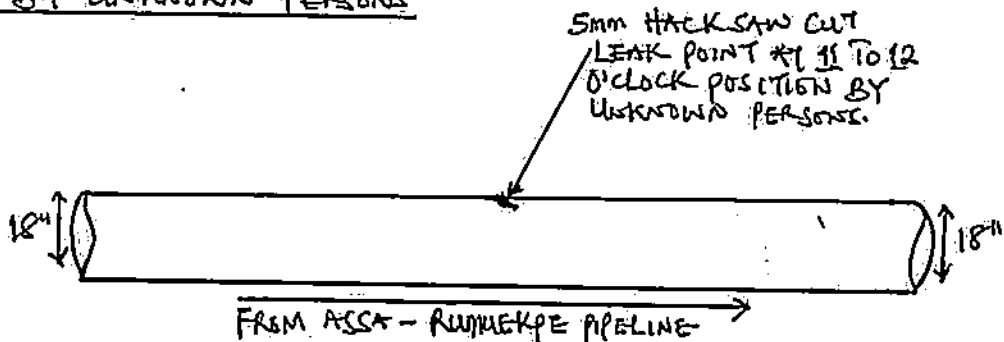
A SECTION OF 18" ASSA - RUMUKEPE PIPELINE AT EGBEDA SHOWING A HACKSAW CUT AT 11 TO 12 O'CLOCK POSITION BY UNKNOWN PERSONS
