# JOINT INVESTIGATION REPORT

INCIDENT NO: 2390249 JIV report S/N: 1030042

1. Fountain Incident Number: 2390249 2. Type of incident\* OIL SPILL  
3. Name of Location 14" OKORDIA - RUMUWERPE PIPELINE  
4. Name of nearest community ULA-IKATA 5. State: RIVERS 6. LGA AHOADA EAST  
7. Type of Production facility/Installation OIL PIPELINE  
8. Asset owner/District THE SHELL PETROLEUM DEVELOPMENT COMPANY OF NIGERIA LIMITED / PIPELINE

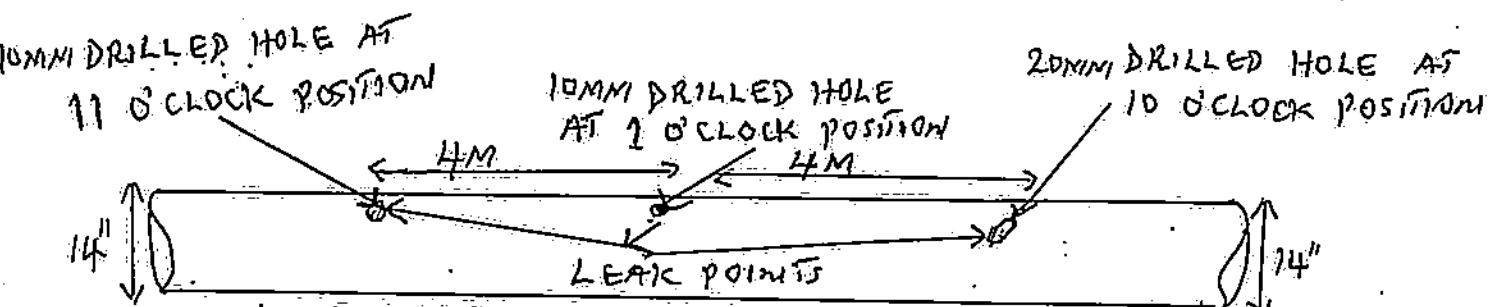
- Drilled hole       Hack saw cut       Tear ( \_\_\_\_\_ )  
 Complete Rupture       Inward dent,       Well head tampering  
 Failed Weld-on illegal hot tap valve       Failed Clamp,       Missing Pipeline/Flowline  
 Crude oil theft (illegal bunkering) point,       Saver-pit over flow       Third party tampering with Clamp  
 Third party tampering with valve setting       Bulging Outward       Third party tampering with flange,  
 Flare System/Bund wall failure       Cold vent       Surge vessel overflow,  
 Valve Failure       Relief valve failure       Accidental 3<sup>rd</sup> party equipment impact  
 Others (specify) \_\_\_\_\_

- Third party interference (Sabotage ; crude theft ; Line theft ; Accidental 3<sup>rd</sup> party damage   
 Operational       Others (including Mystery spills) \_\_\_\_\_

SECTION OF 14" OKORDIA - RUMUKEPE PIPELINE AT ULA-IKATA SHOWING 3 MOS' OF DRILLED HOLE BY UNKNOWN PERSON(S) AT DIFFERENCE POSITIONS.

REPAIR WAS DONE BY CLAMPING.

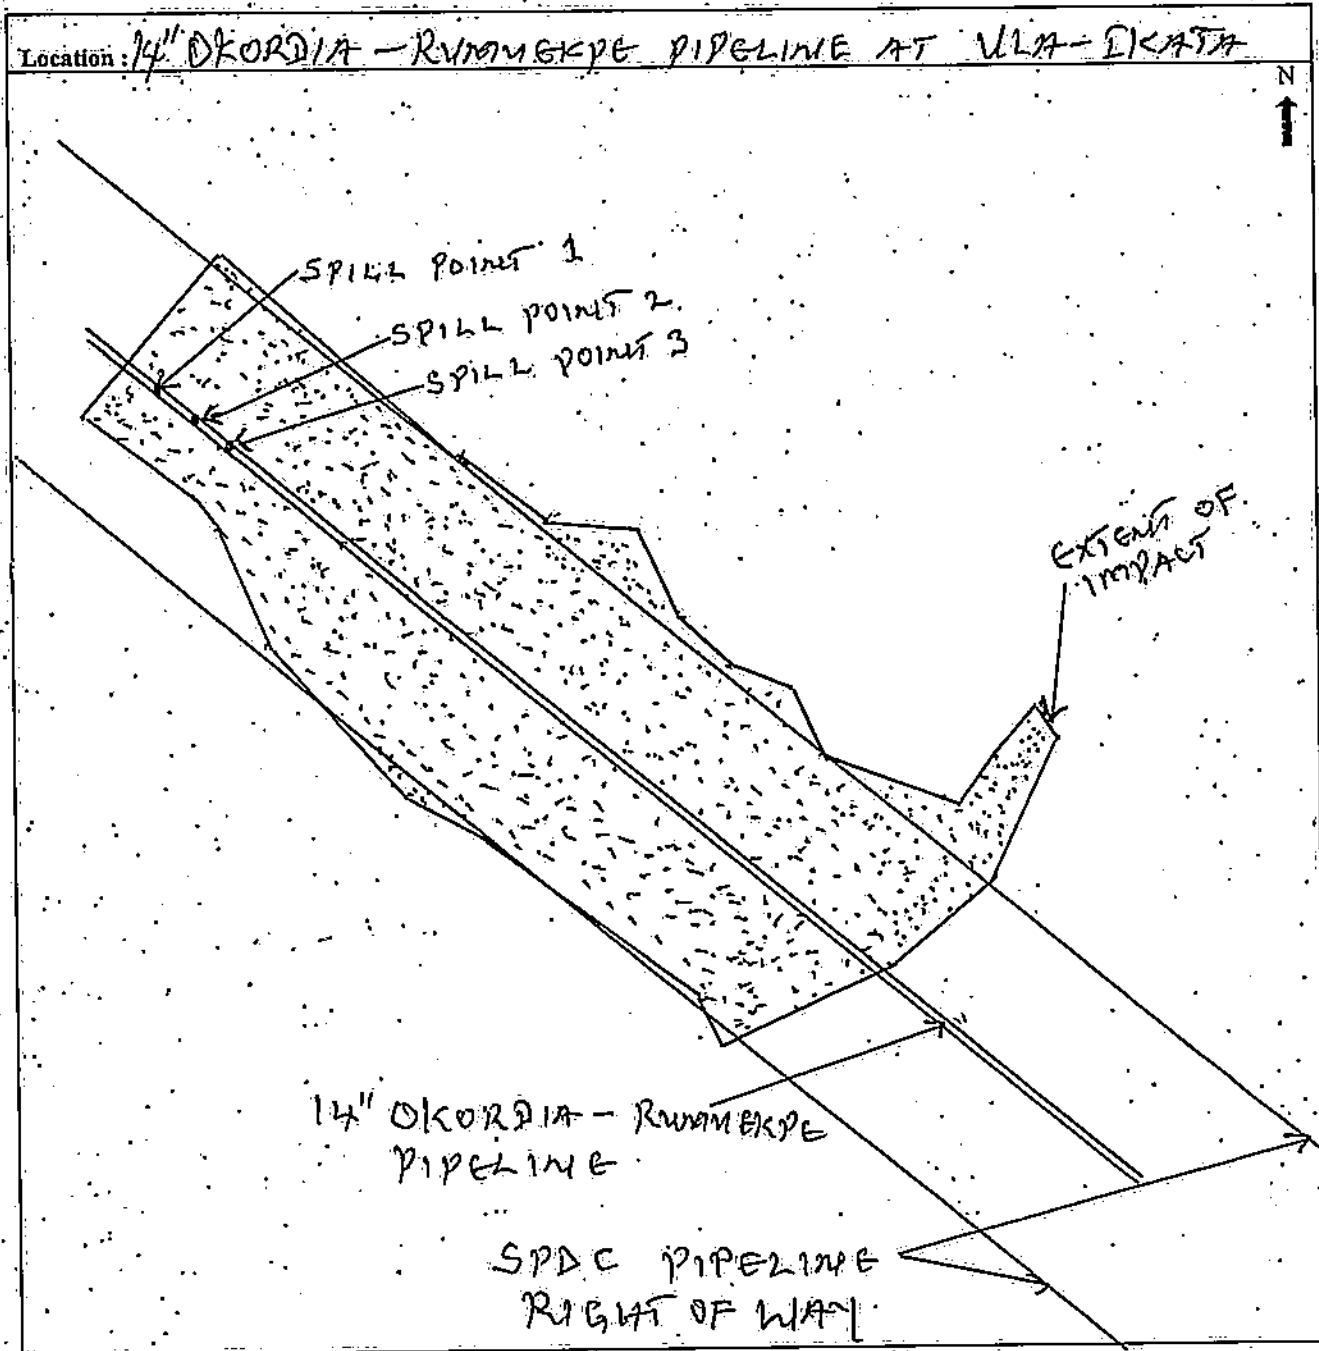
f. Appendix f: Overview sketch of the site

Additional observations around the spill point: THE THREE SPILL INCIDENTS (2390249, 2390307 AND 2390314) ALL OVERLAPPED WITHIN 10 METRES DISTANCE, AS SUCH THEY WERE ALL CAPTURED IN ONE JIV REPORT.
