JOINT INVESTIGATION REPORT

INCIDENT NO: 2412401 JIV report S/N: 1030092

1. Fountain Incident Number: 2412401 2. Type of incident* OIL SPILL
3. Name of Location 20" KOLOCREEK - RUMUEKPE PIPELINE
4. Name of nearest community OKOMA 5. State: RIVERS 6. LGA AHOADA
7. Type of Production facility/Installation OIL PIPELINE
8. Asset owner/District THE SHELL PETROLEUM DEVELOPMENT COMPANY OF NIGERIA LTD. (SPDC)/PIPELINE

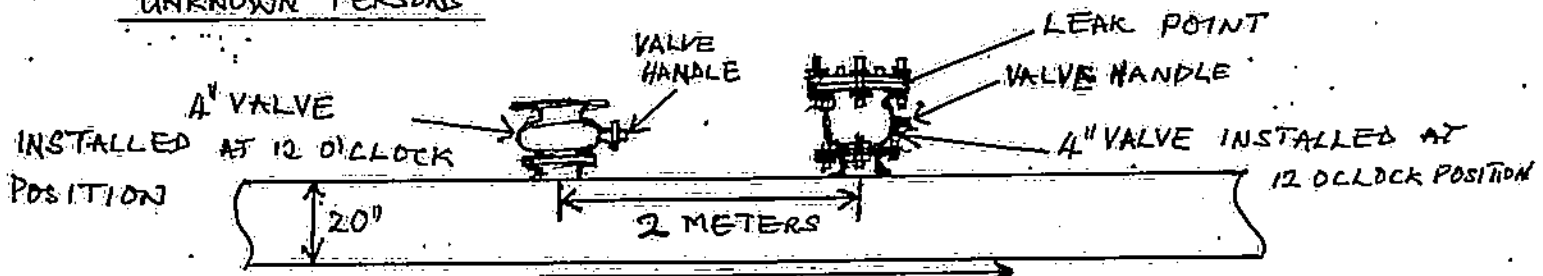
E. GRAPHIC DESCRIPTION OF LEAK POINT (while detail report of the leak point should be contained in the leak report, overview sketch of the site should be added as an appendix 1) A SECTION OF 20" KOLD CREEK - RUMUEKPE PIPELINE AT OKOMA SHOWING 2ND 4" CRUDE THEFT VALVE INSTALLED AT 12 O'CLOCK POSITIONS 2 METERS APART BY UNKNOWN PERSONS
