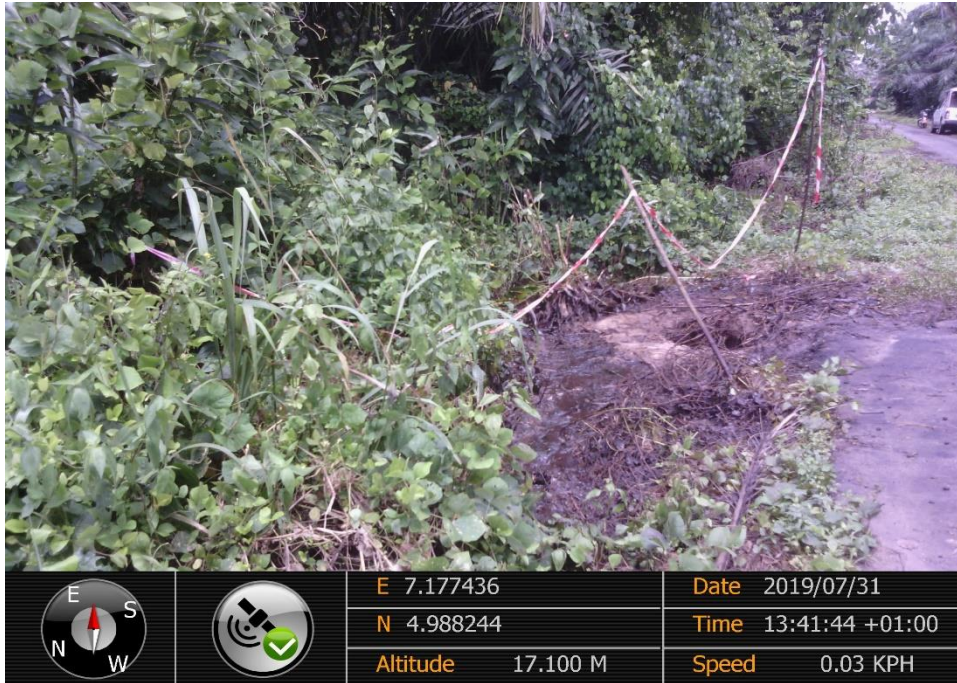
Overview: Part of spill impact on Imo River Well 63T Flowline at Igiriukwu-Owaza. Picture was taken during Joint Investigation of 31st July 2019.

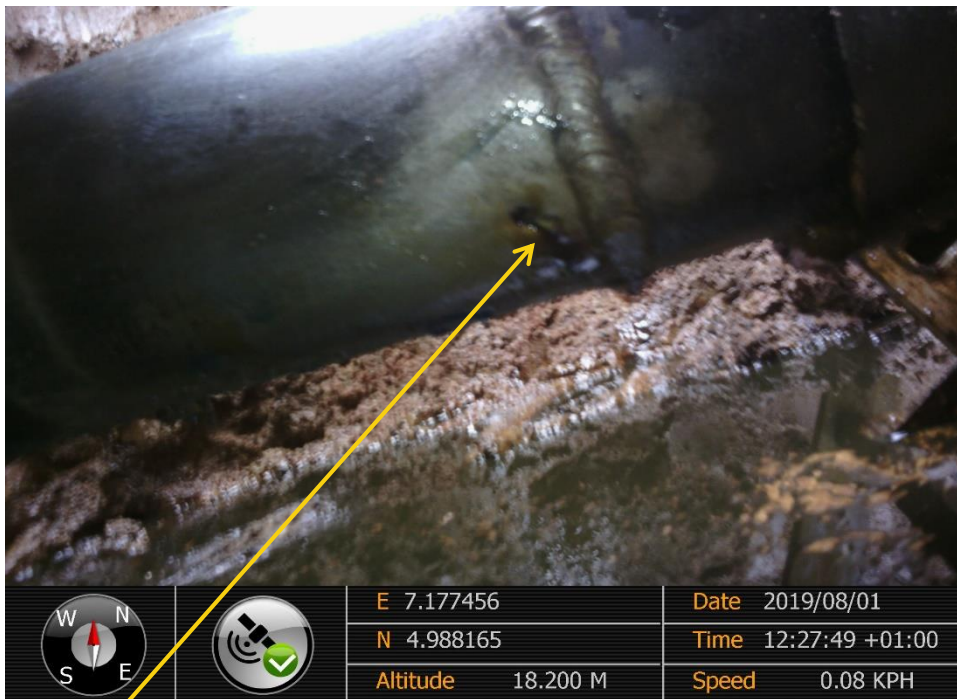
Close-up: Corrosion on Imo River Well 63T Flowline at Igiriukwu-Owaza. Picture was taken during Joint Investigation of 1st August 2019.
