# JOINT INVESTIGATION REPORT

INCIDENT NO: 2410695 JIV report S/N: 1030056

1. Fountain Incident Number: 2410695 2. Type of incident\* OIL SPILL  
3. Name of Location 14" OKORDIA - KUMUKPE (TRUNKLINE) PIPELINE  
4. Name of nearest community IKARMA 5. State: BAYELSA 6. LGA YENAGOA  
7. Type of Production facility/Installation OIL PIPELINE  
8. Asset owner/District THE SHELL PETROLEUM DEVELOPMENT COMPANY OF NIGERIA LIMITED PIPELINE

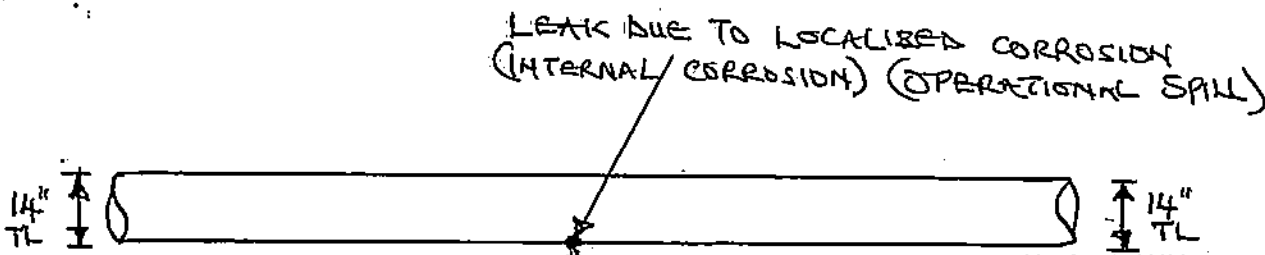
| <input checked="" type="checkbox"/> Others (specify) <u>LOCALIZED CORROSION. (INTERNAL CORROSION)</u> | | |

SECTIONAL VIEW OF 14" OKORDIA - RUMUEKPE TRUNKING PIPELINE AT IKARAMA: SHOWING LEAK DUE TO LOCALIZED CORROSION.

RECOVERY AND REPAIR WORK ARE ON-GOING

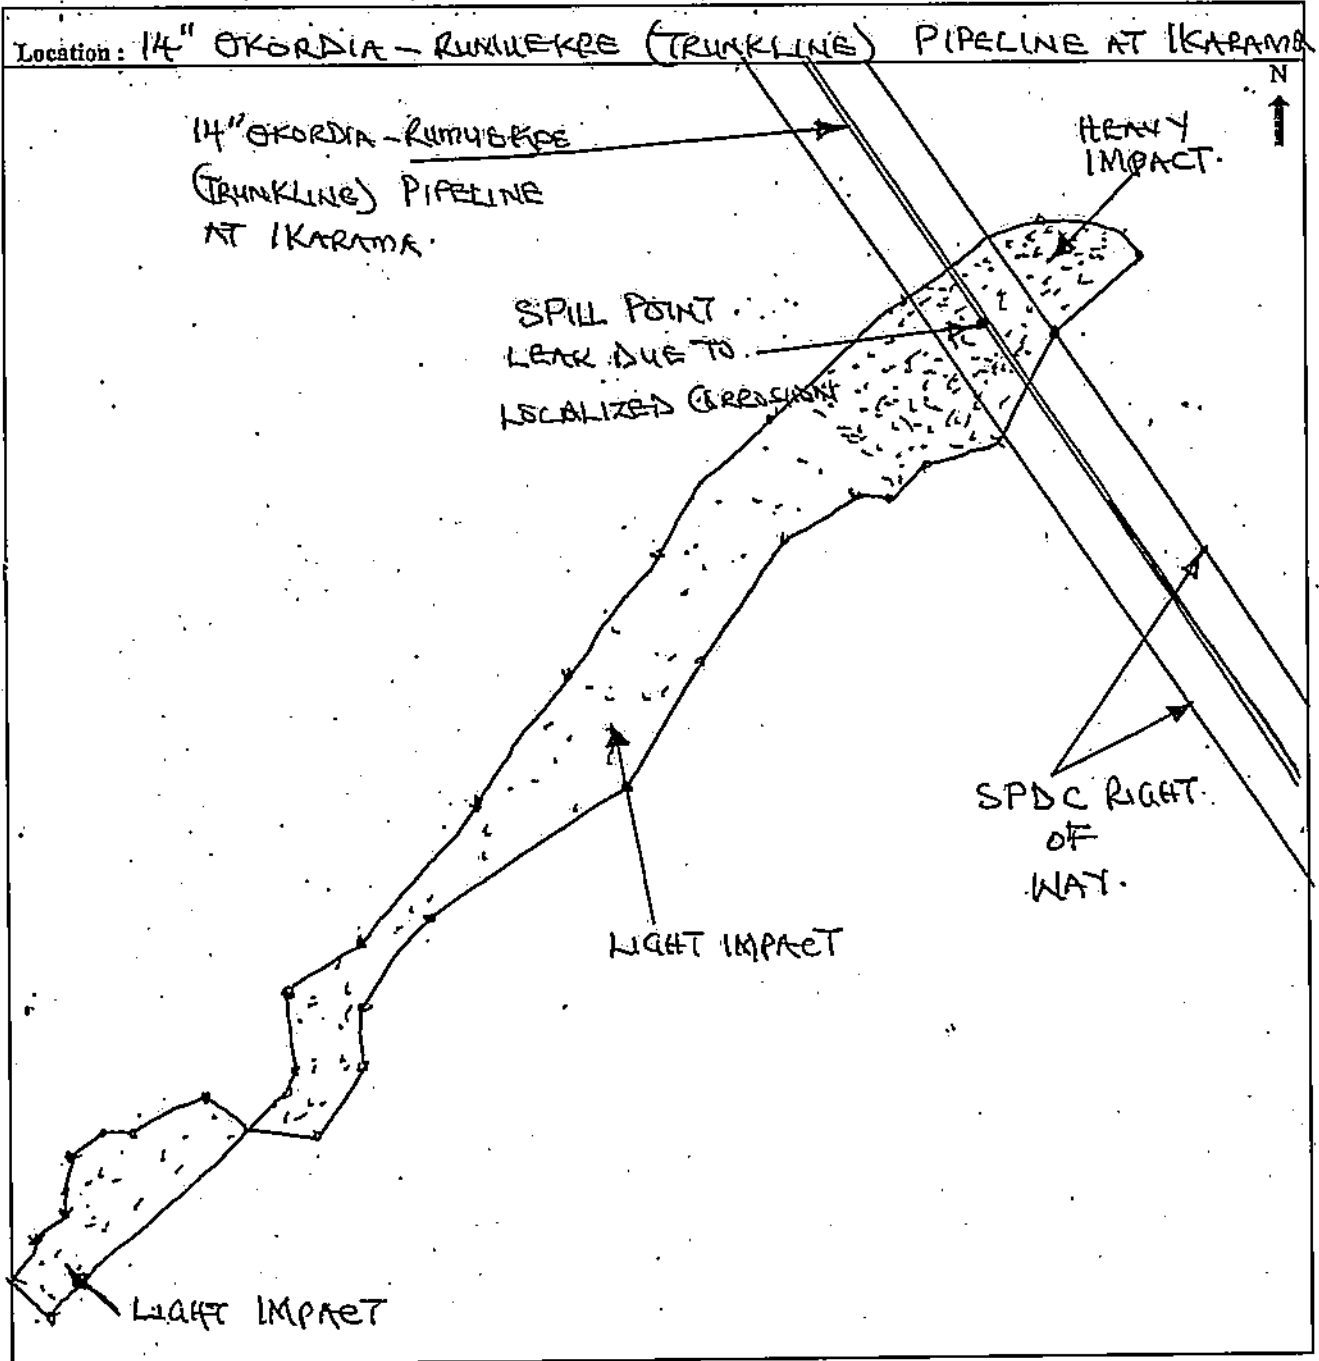
f. Appendix d: Overview sketch of the site

Additional observations around the spill point: THE JOINT INVESTIGATION TEAM OBSERVED THAT THE IMPACTED AREA FROM THE INCIDENT OVERLAPS THE PREVIOUSLY IMPACTED AREA FROM INCIDENT NUMBER 2018-2097834 AND 2018-2076704.

- Total calculated area of impact 1.188796 HECTARES
- Impact within SPDC R.O.W. YES
- Impact outside SPDC R.O.W. YES
