JOINT INVESTIGATION REPORT

INCIDENT NO: 2367006 JIV report S/N: 1030014

1. Fountain Incident Number: 2367006 2. Type of incident* OIL SPILL
3. Name of Location 12" IMO RIVER - OGAE PIPELINE
4. Name of nearest community UZUAKU 5. State: ABIA 6. LGA UKWA WEST
7. Type of Production facility/Installation OIL PIPELINE
8. Asset owner/District THE SHELL PETROLEUM DEVELOPMENT COMPANY OF NIGERIA LTD (SPDC) / PIPELINE

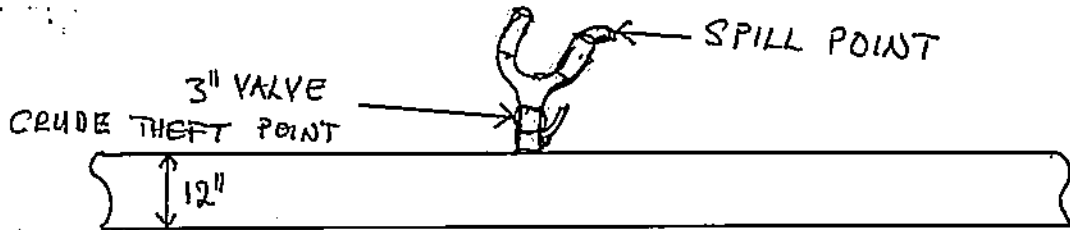
| <input checked="" type="checkbox"/> Crude oil theft (illegal bunkering) point, | <input type="checkbox"/> Saver-pit over flow | <input type="checkbox"/> Third party tampering with Clamp |

A SECTION OF 12" IMO RIVER - OGALE PIPELINE AT UZUAKU SHOWING A 3" VALVE CRUDE THEFT POINT INSTALLED AT 12 O'CLOCK POSITION BY UNKNOWN PERSONS.

REPAIR BY CLAMPING

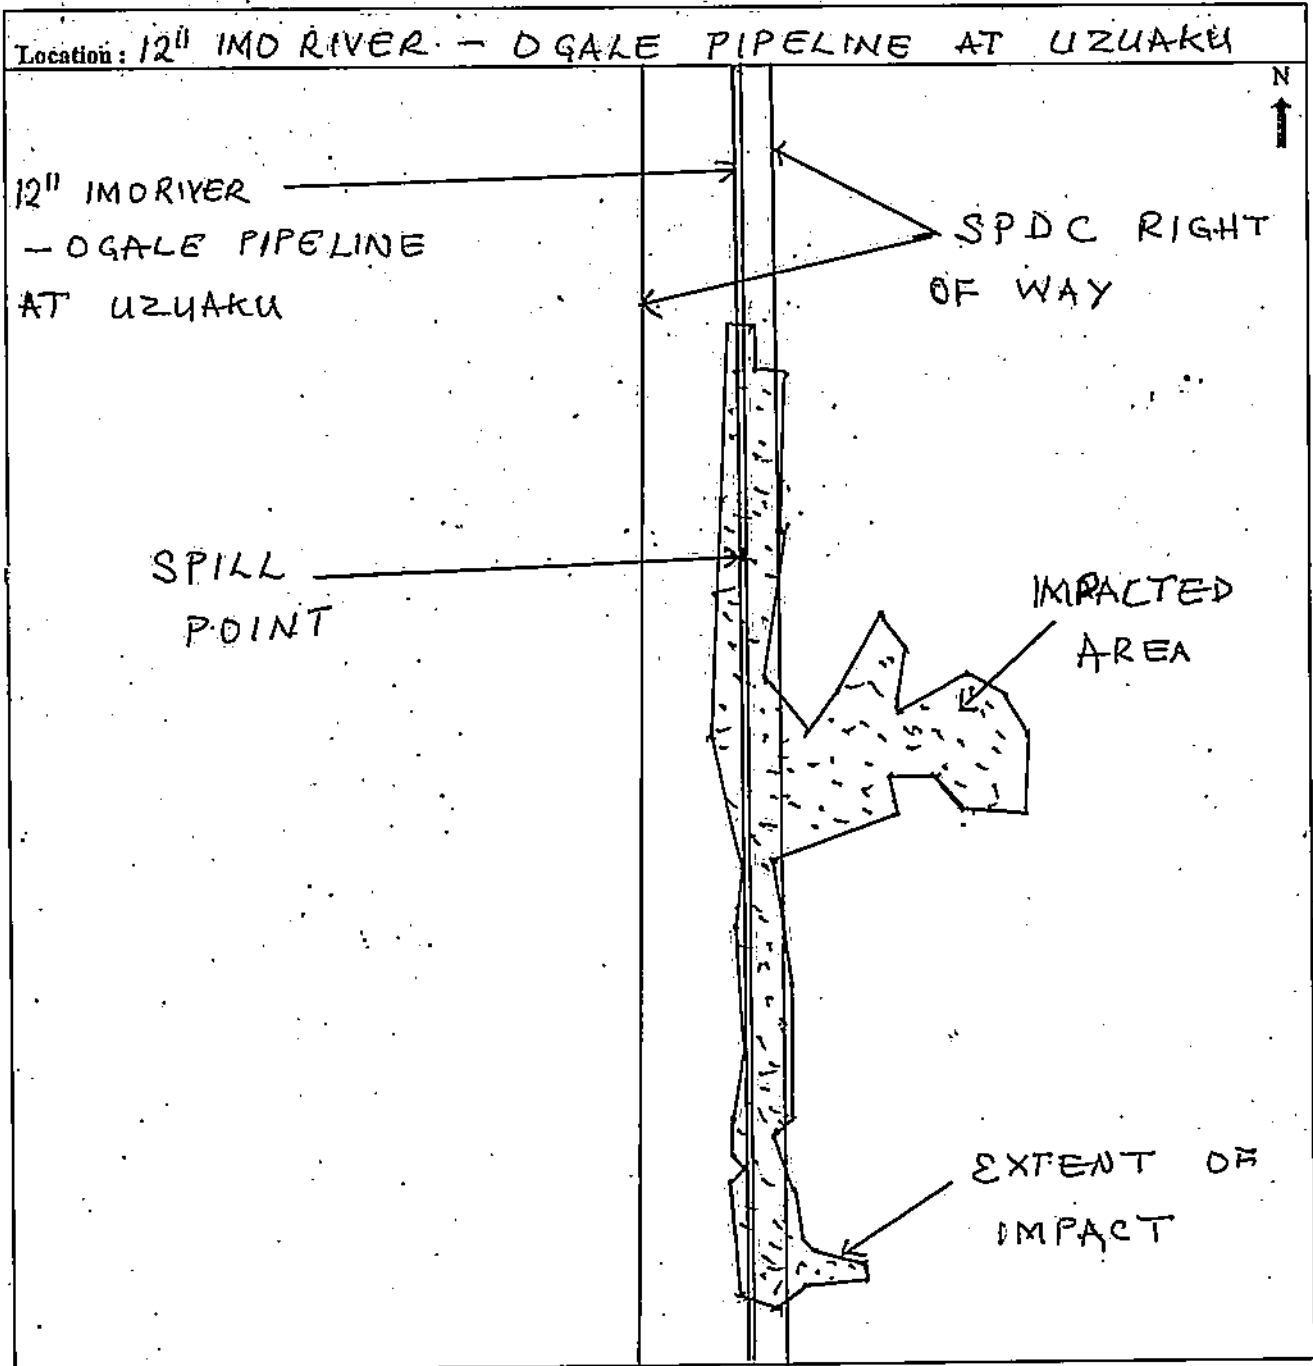
f. Appendix 1: Overview sketch of the site

- Total calculated area of impact: 0.09Ha
- Impact within SPDC R.O.W.: YES
- Impact outside SPDC R.O.W.: YES
