JOINT INVESTIGATION REPORT

INCIDENT NO: 2367018 JIV report S/N: 1030021

- 1. Fountain Incident Number: 2367018 2. Type of incident* OIL SPILL
- 3. Name of Location 8" OBIGBO NORTH - NEW ELELENWA PIPELINE
- 4. Name of nearest community UMUSONYA 5. State: RIVERS 6. LGA OYIGBO
- 7. Type of Production facility/Installation OIL PIPELINE
- 8. Asset owner/District THE SHELL PETROLEUM DEVELOPMENT COMPANY OF NIGERIA LIMITED / PIPELINE

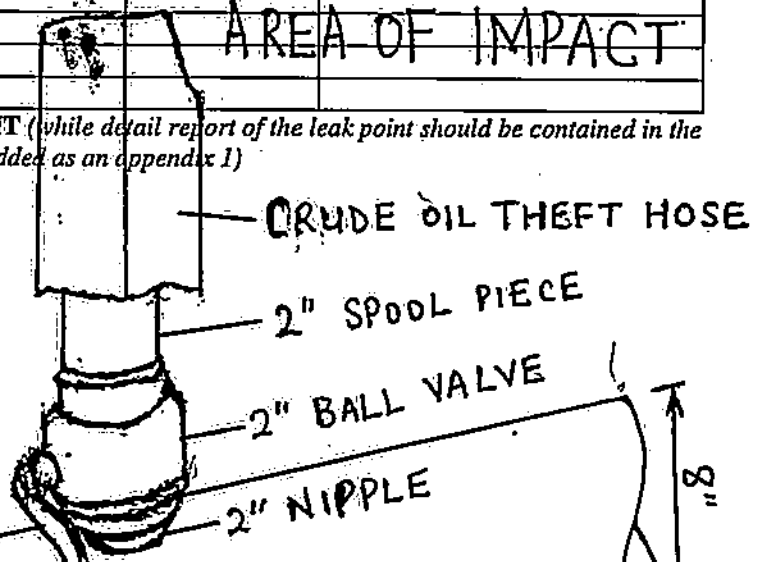
E. GRAPHIC DESCRIPTION OF LEAK POINT (while detail report of the leak point should be contained in the leak report, overview sketch of the site should be added as an appendix 1)

Additional observations around the spill point: THE SPILL POINT WAS NOTICED TO BE THE SAME LOCATION AS A PREVIOUSLY REPORTED NON-LEAKING INCIDENT POINT (INCIDENT NO. 2286262).

SECTION OF
8" OBIGBO NORTH -
NEW ELELENWA
PIPELINE AT
UMUSONYA SHOWING
ONE (1) NO. 2" CRUDE
OIL THEFT POINT

INSTALLED AT
12 O' CLOCK POSITION
BY UNKNOWN PERSON(S)

AND REPAIR WAS EFFECTED ON THE AFFECTED PIPELINE SECTION BY CLAMPING.
