# JOINT INVESTIGATION REPORT

INCIDENT NO: 2365359 JIV report S/N: 1030011

1. Fountain Incident Number: 2365359 2. Type of incident: OIL SPILL  
3. Name of Location: 18" ASSA-RUMUEKPE PIPELINE  
4. Name of nearest community: IGBEDA 5. State: RIVERS 6. LGA: EMOHUA  
7. Type of Production facility/Installation: OIL PIPELINE  
8. Asset owner/District: THE SHELL PETROLEUM DEVELOPMENT COMPANY OF NIGERIA LIMITED PIPELINE

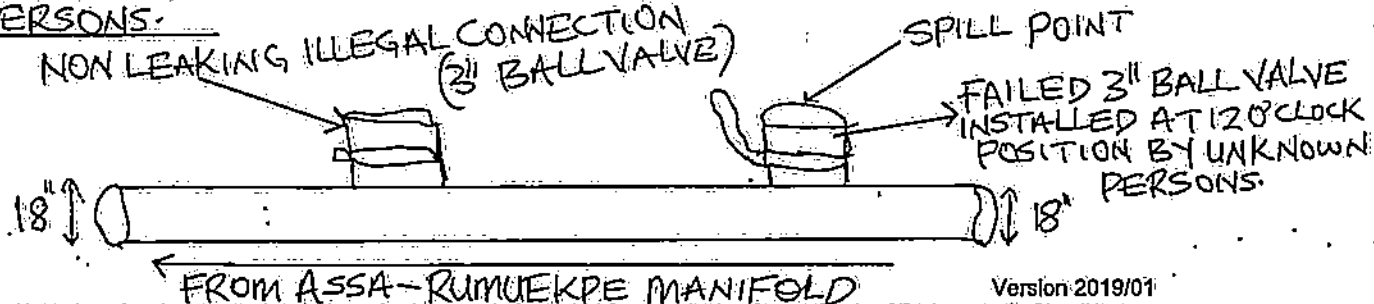
**E. GRAPHIC DESCRIPTION OF LEAK POINT** (while detail report of the leak point should be contained in the leak report, overview sketch of the site should be added as an appendix 1)

| <input checked="" type="checkbox"/> Crude oil theft (illegal bunkering) point, | <input type="checkbox"/> Saver-pit over flow | <input type="checkbox"/> Third party tampering with Clamp |

A SECTION OF 18" ASSA-RUMUEKPE PIPELINE AT EGBEDA SHOWING 1 FAILED 3" BALL VALVE AND 1 NON LEAKING INSTALLED AT 12 O'CLOCK POSITION BY UNKNOWN PERSONS.
