JOINT INVESTIGATION REPORT

INCIDENT NO: 2365705 JIV report S/N: 1030013

1. Fountain Incident Number: 2365705 2. Type of incident: OIL SPILL
3. Name of Location: 12" IMO RIVER 2 - OGALE PIPELINE
4. Name of nearest community: OWAZA 5. State: ABIA 6. LGA: UKWA - WEST
7. Type of Production facility/Installation: OIL PIPELINE
8. Asset owner/District: THE SHELL PETROLEUM DEVELOPMENT COMPANY OF NIGERIA LIMITED/PIPELINE

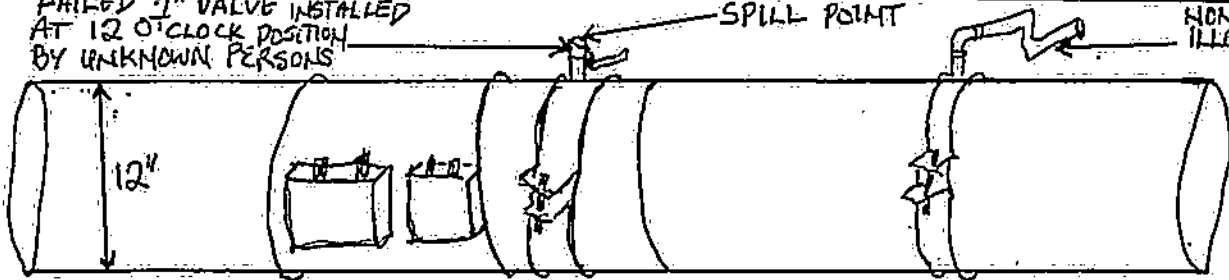
A SECTION SHOWING A FAILED 2" VALVE INSTALLED AT 12 O'CLOCK POSITION BY UNKNOWN PERSONS ON 12" IMO RIVER-OGALE PIPELINE AT OKLAZA

FAILED 2" VALVE INSTALLED AT 12 O'CLOCK POSITION BY UNKNOWN PERSONS

SPILL POINT

NON LEAKING ILLEGAL CONNECTION

REPAIR AND CRUDE OIL RECOVERY ACTIVITIES ONGOING
