# JOINT INVESTIGATION REPORT

INCIDENT NO: 2372941 JIV report S/N: 1030003

1. Fountain Incident Number: 2372941 2. Type of incident\* OIL SPILL  
3. Name of Location 18<sup>th</sup> ASSA - RUMUWERPE PIPELINE  
4. Name of nearest community ANARRA 5. State: IMO 6. LGA OHAI/EBBEMA  
7. Type of Production facility/Installation OIL PIPELINE  
8. Asset owner/District THE SHELL PETROLEUM DEVELOPMENT COMPANY  
OF NIGERIA LIMITED (DPR) / PIPELINE

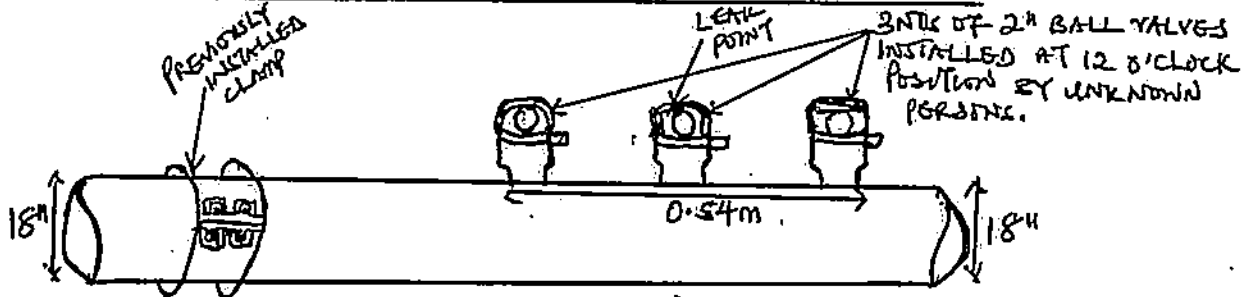
**E. GRAPHIC DESCRIPTION OF LEAK POINT** (while detail report of the leak point should be contained in the leak report, overview sketch of the site should be added as an appendix 1)

| <input checked="" type="checkbox"/> Failed Weld-on illegal hot tap valve | <input type="checkbox"/> Failed Clamp, | <input type="checkbox"/> Missing Pipeline/Flowline |
| <input checked="" type="checkbox"/> Crude oil theft (illegal bunkering) point, | <input type="checkbox"/> Saver-pit over flow | <input type="checkbox"/> Third party tampering with Clamp |

A SECTION OF 18" ASSA-RUMUKE PIPELINE SHOWING 3 NOS OF 2" BALL VALVES INSTALLED AT 12 O'CLOCK POSITION BY UNKNOWN PERSONS.

REPAIR BY CLAMPING
