JOINT INVESTIGATION REPORT

INCIDENT NO: 2369724 JIV report S/N: 1030024

1. Fountain Incident Number: 2369724 2. Type of incident* OTL SPILL
3. Name of Location 18th ASSA - RUMUKEPE PIPELINE
4. Name of nearest community AWARRA 5. State: IMO 6. LGA OTAJI / EGBEMA
7. Type of Production facility/Installation OIL PIPELINE
8. Asset owner/District THE SHELL PETROLEUM DEVELOPMENT COMPANY OF NIGERIA LIMITED (SPDC) / PIPELINE

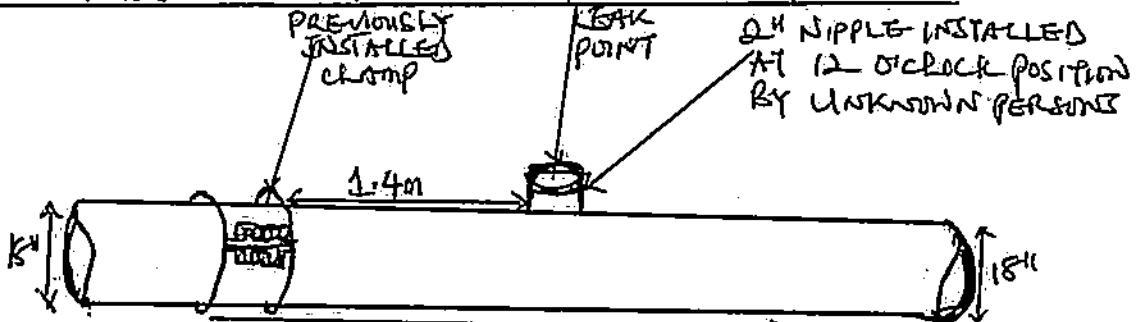
E. GRAPHIC DESCRIPTION OF LEAK POINT (while detail report of the leak point should be contained in the leak report, overview sketch of the site should be added as an appendix 1)

| <input checked="" type="checkbox"/> Crude oil theft (illegal bunkering) point, | <input type="checkbox"/> Saver-pit over flow | <input type="checkbox"/> Third party tampering with Clamp |

THE SECTION OF 16" ASSA-RUMUERGE PIPELINE SHOWING A PREVIOUSLY INSTALLED CLAMP AND A 2" NIPPLE INSTALLED AT 12 O'CLOCK POSITION BY UNKNOWN PERSONS

CRUDE OIL RECOVERY AND REPAIR ACTIVITIES
