JOINT INVESTIGATION REPORT

INCIDENT NO: 2378490 JIV report S/N: 1030033

1. Fountain Incident Number: 2378490 2. Type of incident* OIL SPILL
3. Name of Location 12" IMO RIVER - OGAGE PIPELINE
4. Name of nearest community OWAZA 5. State: ABIA 6. LGA UKWA WEST
7. Type of Production facility/Installation OIL PIPELINE
8. Asset owner/District THE SHELL PETROLEUM DEVELOPMENT COMPANY OF NIGERIA LTD (SPDC) / PIPELINE

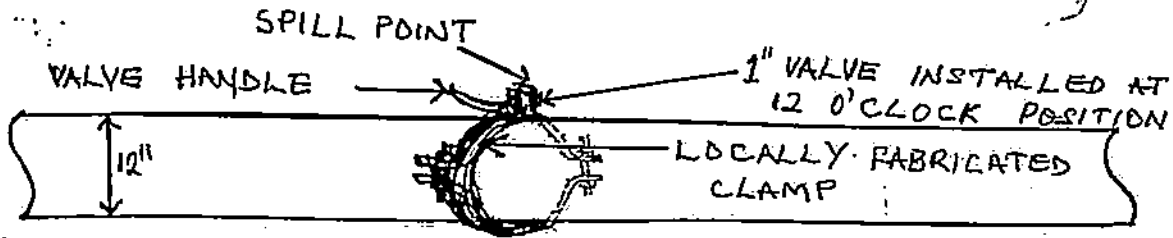
E. GRAPHIC DESCRIPTION OF LEAK POINT (while detail report of the leak point should be contained in the leak report, overview sketch of the site should be added as an appendix 1) A SECTION OF 12" IMO RIVER - OGALE PIPELINE AT OKAZA SHOWING 1" VALVE CRUDE THEFT POINT INSTALLED AT 12 O'CLOCK POSITION BY UNKNOWN PERSONS.

IMO RIVER TO OGALE

REPAIR BY CLAMPING
