JOINT INVESTIGATION REPORT

INCIDENT NO: 2367040 JIV report S/N: 1030007

1. Fountain Incident Number: 2367040 2. Type of incident: OIL SPILL
3. Name of Location: 14" OKORDA-RUMUKEPE PIPELINE
4. Name of nearest community: OSHUKA 5. State: RIVERS 6. LGA: ATIADA WEST
7. Type of Production facility/Installation: OIL PIPELINE
8. Asset owner/District: THE SHELL PETROLEUM DEVELOPMENT COMPANY OF NIGERIA LIMITED/PIPELINE

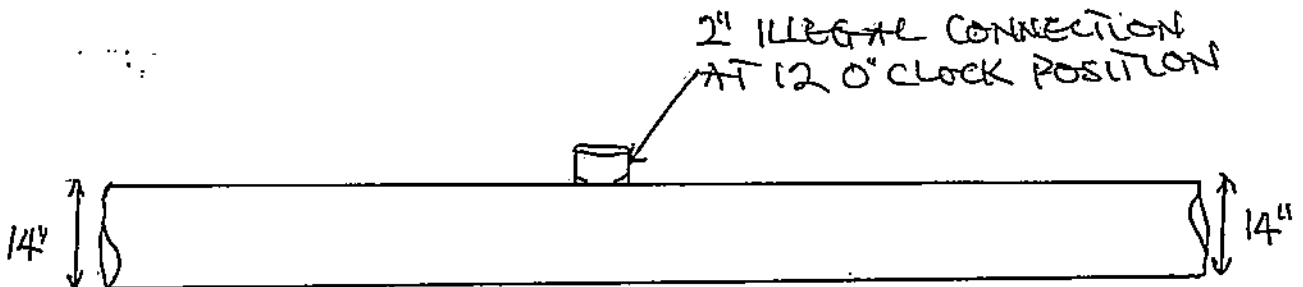
Additional observations around the spill point: THE SPILL INCIDENT POINT WAS OBSERVED TO BE THE SAME LOCATION PREVIOUSLY REPORTED INCIDENT OF CRUDE OIL PRESENCE ON THE SPDC RIGHT OF WAY (FID 2321228). JIV WAS NOT CONDUCTED.

E. GRAPHIC DESCRIPTION OF LEAK POINT (while detail report of the leak point should be contained in the leak report, overview sketch of the site should be added as an appendix 1) A SECTION OF 14" OKORDIA - RUMUEKPE TRUNKLINE AT OSHIKA SHOWING A 2" ILLEGAL CONNECTION INSTALLED AT 12 O'CLOCK POSITION BY UNKNOWN PERSONS

REPAIR BY CLAMPING ONGOING
