JOINT INVESTIGATION REPORT

INCIDENT NO: 2370675 JIV report S/N: 1030012

1. Fountain Incident Number: 2370675 2. Type of incident* OIL SPILL
3. Name of Location 14" OKORIDIA-RUNAWEKPE PIPELINE
4. Name of nearest community AKARA - OLU 5. State RIVERS 6. LGA HOADA WEST
7. Type of Production facility/Installation OIL PIPELINE
8. Asset owner/District THE SHELL PETROLEUM DEVELOPMENT COMPANY OF NIGERIA LIMITED/PIPELINE

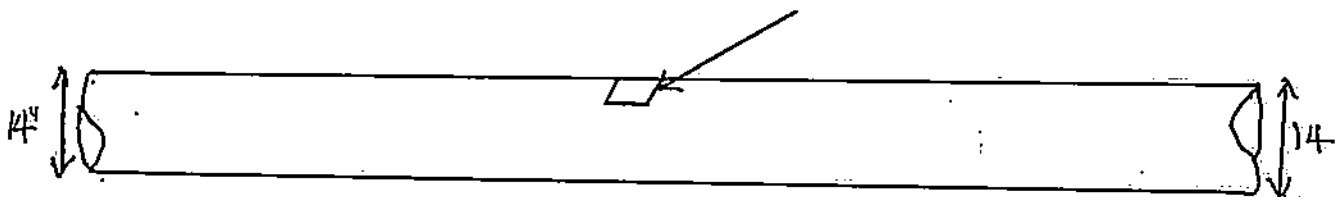
E. GRAPHIC DESCRIPTION OF LEAK POINT (while detail report of the leak point should be contained in the leak report, overview sketch of the site should be added as an appendix 1) A SECTION OF 14" OKORDIA - RUMUEKPE PIPELINE AT AKARA OLU SHOWING A HACKSAW CUT AT 12 O'CLOCK POSITION BY UNKNOWN PERSONS.

HACKSAW CUT AT 12 O'CLOCK POSITION.

REPAIR BY CLAMPING ONGOING.
