JOINT INVESTIGATION REPORT

INCIDENT NO: 2387729 JIV report S/N: 1030041

1. Fountain Incident Number: 2387729 2. Type of incident* OIL SPILL
3. Name of Location 14" OKORDIA - RUMUKEPE PIPELINE
4. Name of nearest community EDEOHA 5. State: RIVERS 6. LGA AHOADA EAST
7. Type of Production facility/Installation OIL PIPELINE
8. Asset owner/District THE SHELL PETROLEUM DEVELOPMENT COMPANY OF NIGERIA LIMITED / PIPELINE

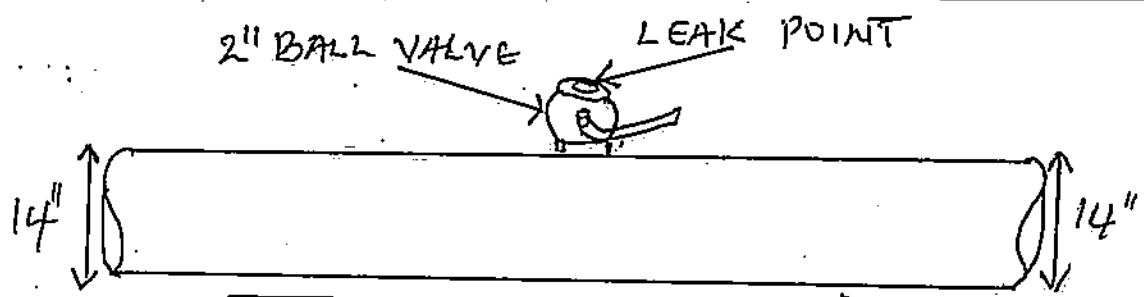
| <input checked="" type="checkbox"/> Failed Weld-on illegal hot tap valve | <input type="checkbox"/> Failed Clamp, | <input type="checkbox"/> Missing Pipeline/Flowline |
| <input checked="" type="checkbox"/> Crude oil theft (illegal bunkering) point, | <input type="checkbox"/> Saver-pit over flow | <input type="checkbox"/> Third party tampering with Clamp |

SECTION OF 14" OKORDIA-RUMUENGE PIPELINE AT EDEGHA SHOWING CRUDE OIL LEAK POINT AT 12 O'CLOCK POSITION.
