JOINT INVESTIGATION REPORT

INCIDENT NO: 2402031 JIV report S/N: 1030052

1. Fountain Incident Number: 2402031 2. Type of incident* OIL SPILL
3. Name of Location 24" NKPKU - BOMU PIPELINE
4. Name of nearest community SIME 5. State: RIVERS 6. LGA TAI
7. Type of Production facility/Installation OIL PIPELINE
8. Asset owner/District THE SHELL PETROLEUM DEVELOPMENT COMPANY OF NIGERIA LIMITED / PIPELINE.

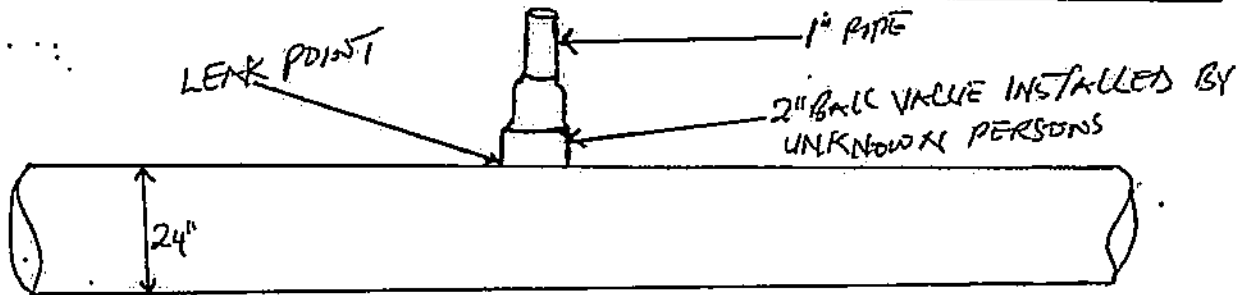
Additional observations around the spill point: THE JOINT INVESTIGATION TEAM OBSERVED CRUDE OIL LEAK ON AN EARLIER REPORTED RUSTY / NON-LEAKING ILLEGAL CONNECTION (INCIDENT NO. 2362025)

E. GRAPHIC DESCRIPTION OF LEAK POINT (while detail report of the leak point should be contained in the leak report, overview sketch of the site should be added as an appendix 1) A SECTION OF 24" NKPDKU - BDMU PIPELINE AT SITE SHOWING 1 NO 2" BALL VALVE INSTALLED AT 12 O'CLOCK POSITION BY UNKNOWN PERSONS.

REPAIR BY CLAMPING AND CRUDE OIL RECOVERY
ARE ONGOING.
